County of Ventura  
July 22, 2024  
Cultural Heritage Board Meeting  
Item 6a  
Exhibit 2 – Before Photographs

Billiwhack Ranch

## Building H2

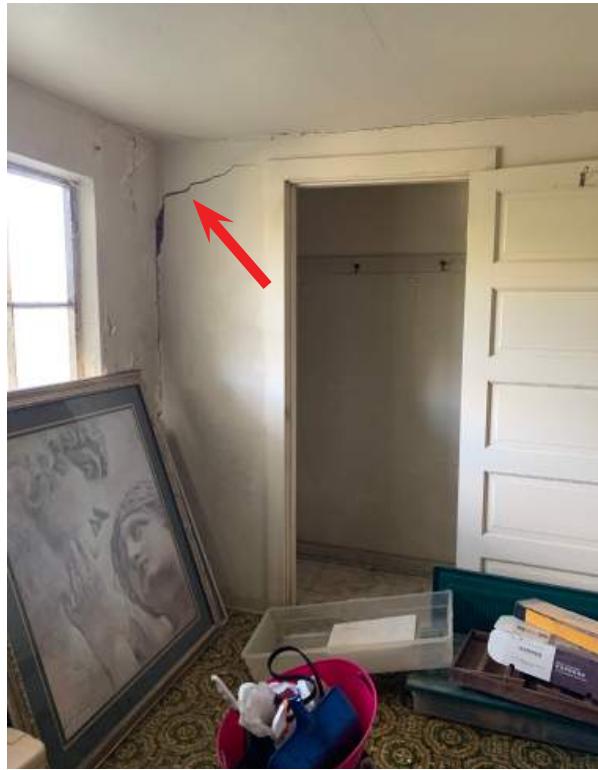
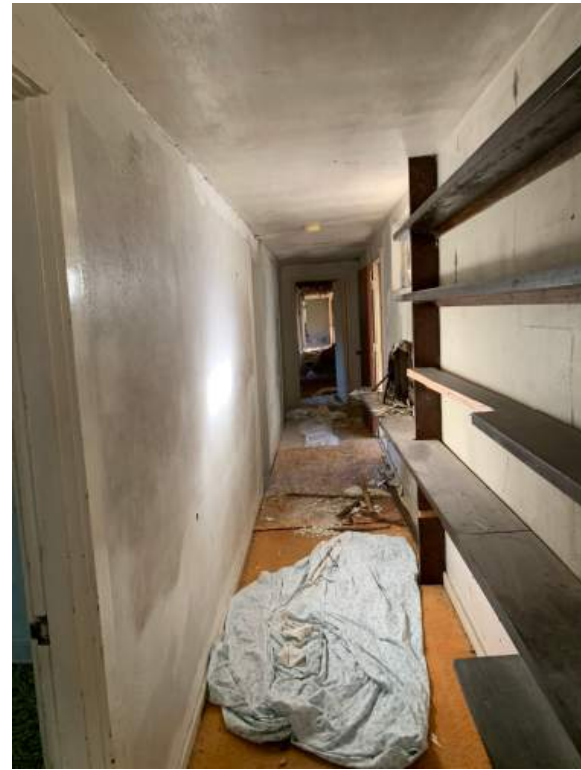
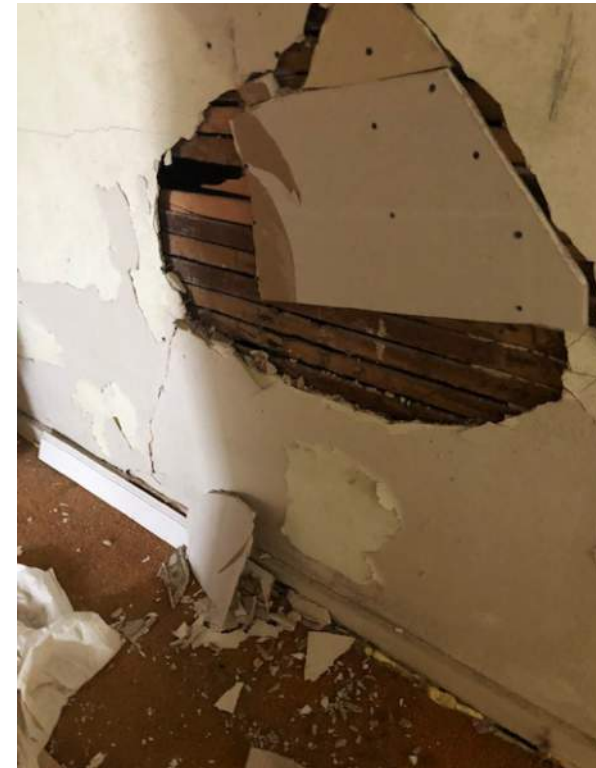
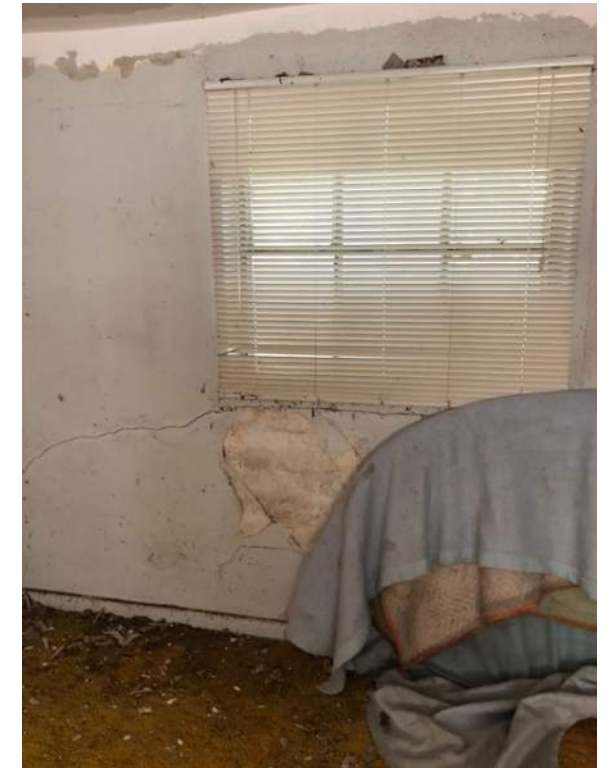
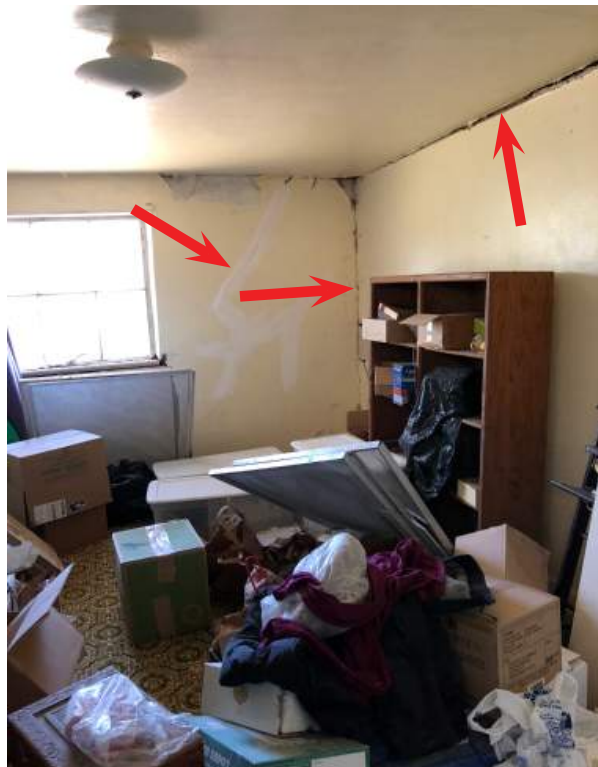
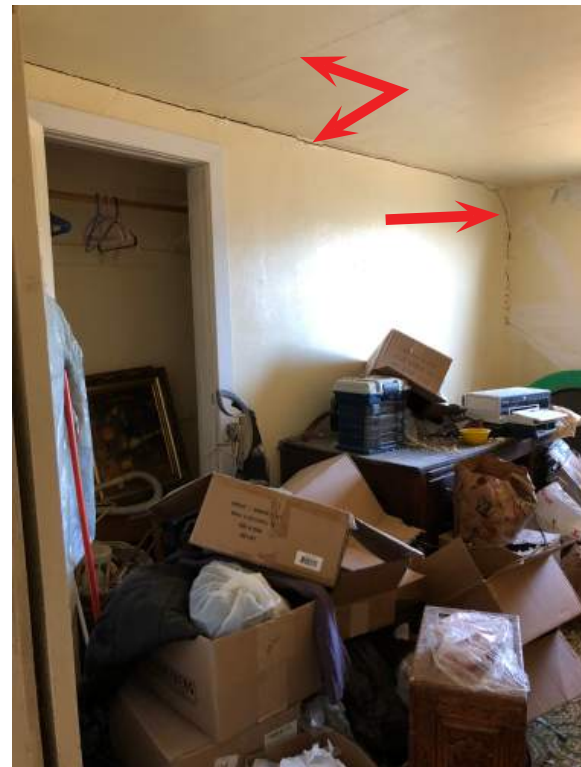
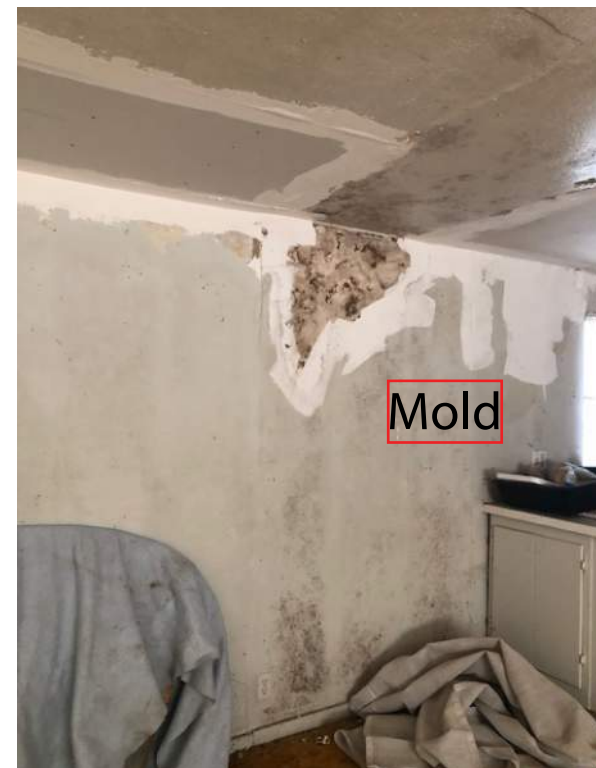
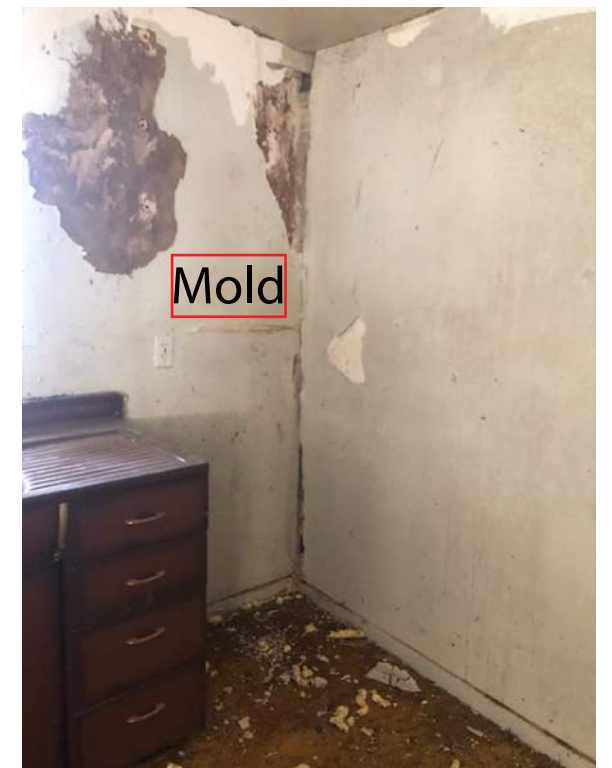
Interior Damage Pre Demo: Floor, Walls, Ceiling (Exposed Damage)  
Billiwhack Ranch

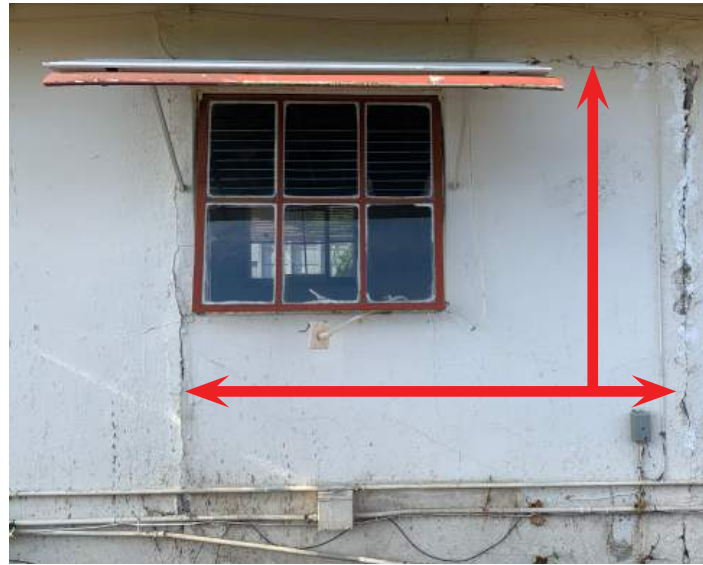
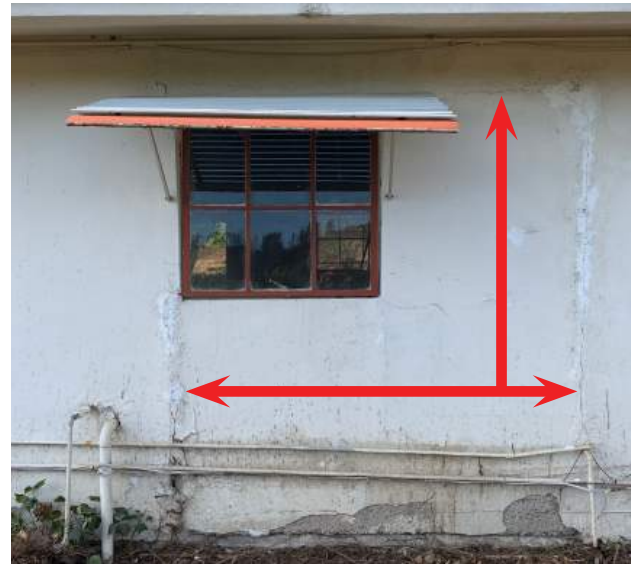
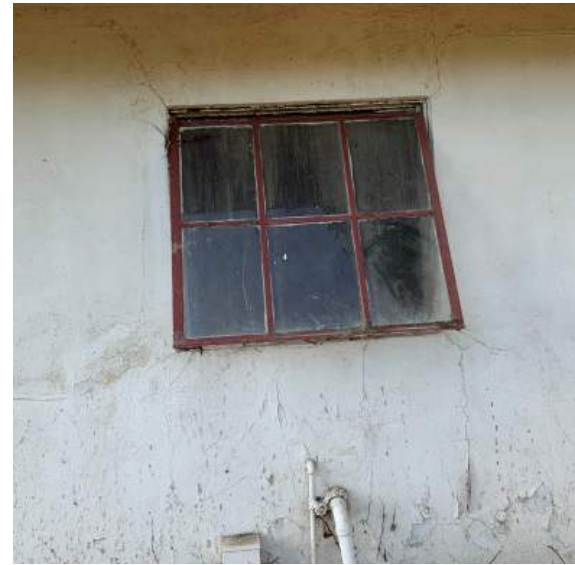
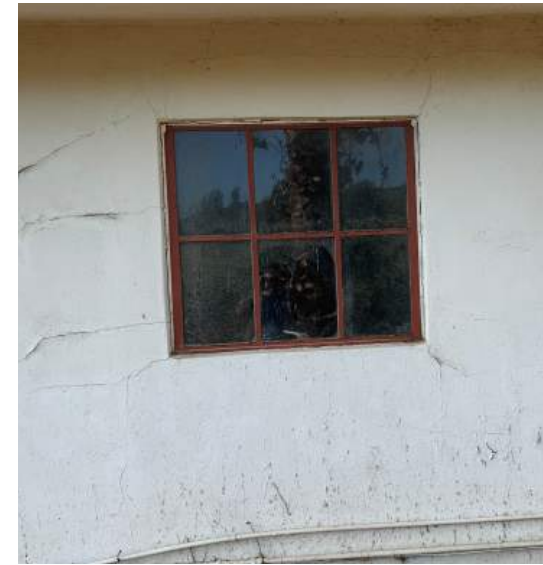
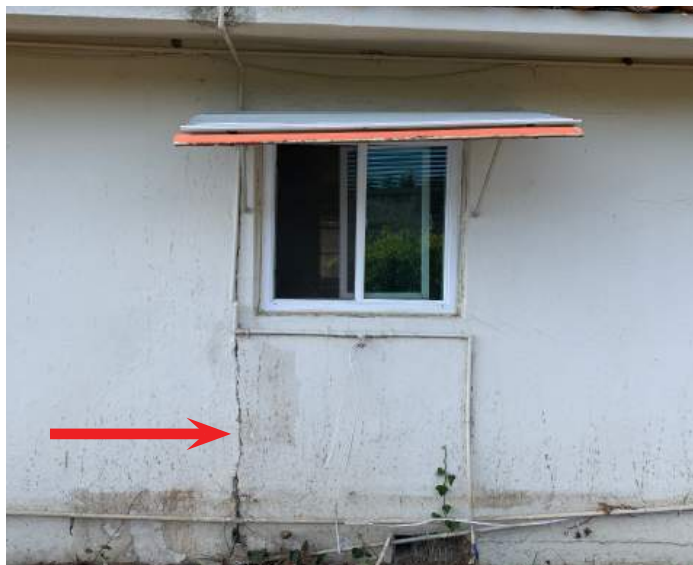
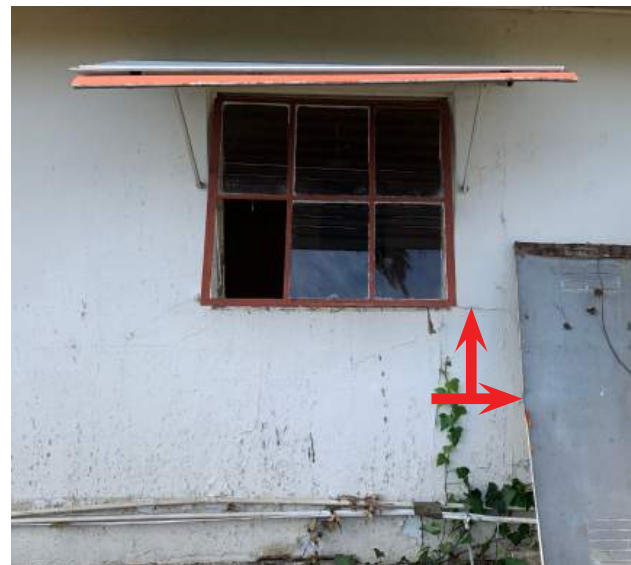
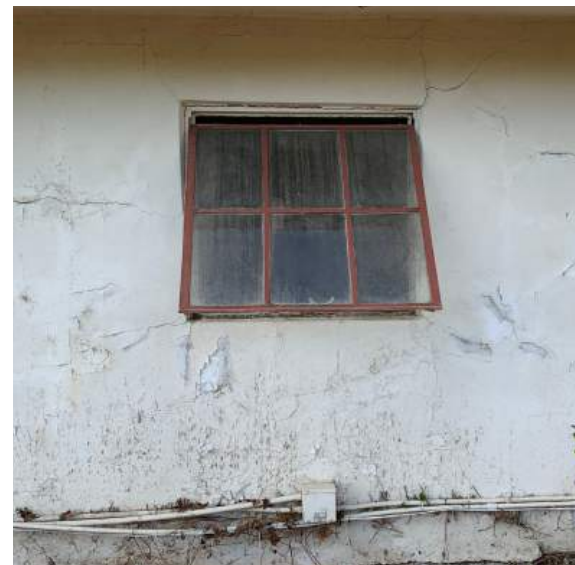
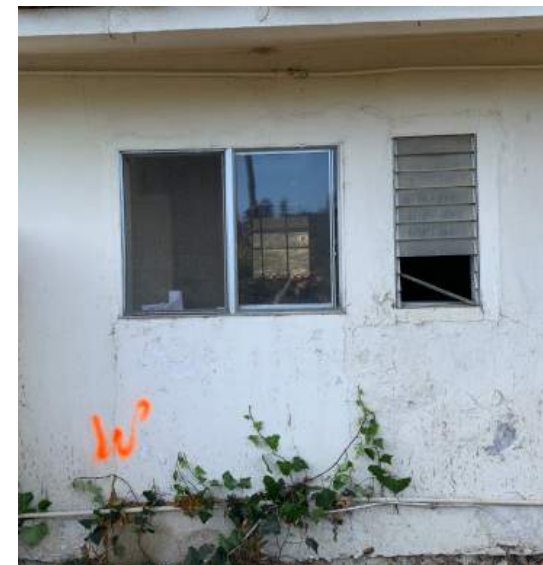
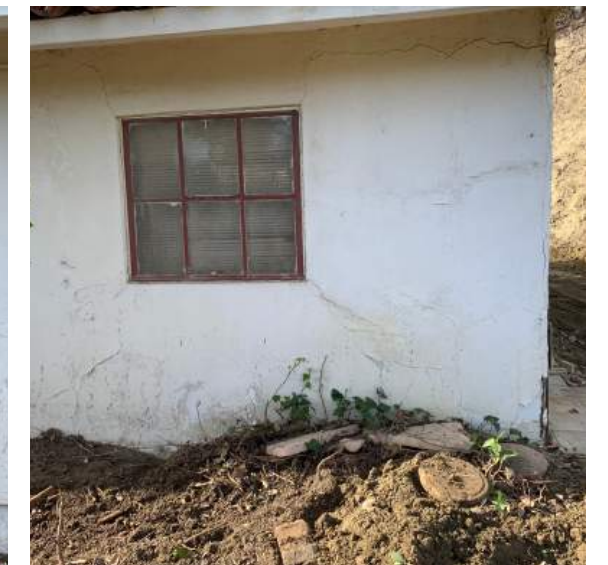
South Side:  
Stress fractures & damage  
visible at each window

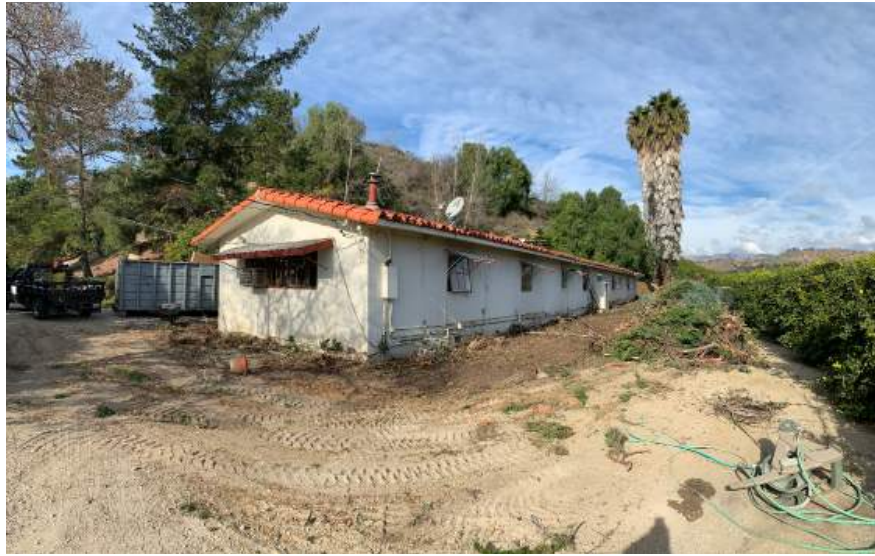
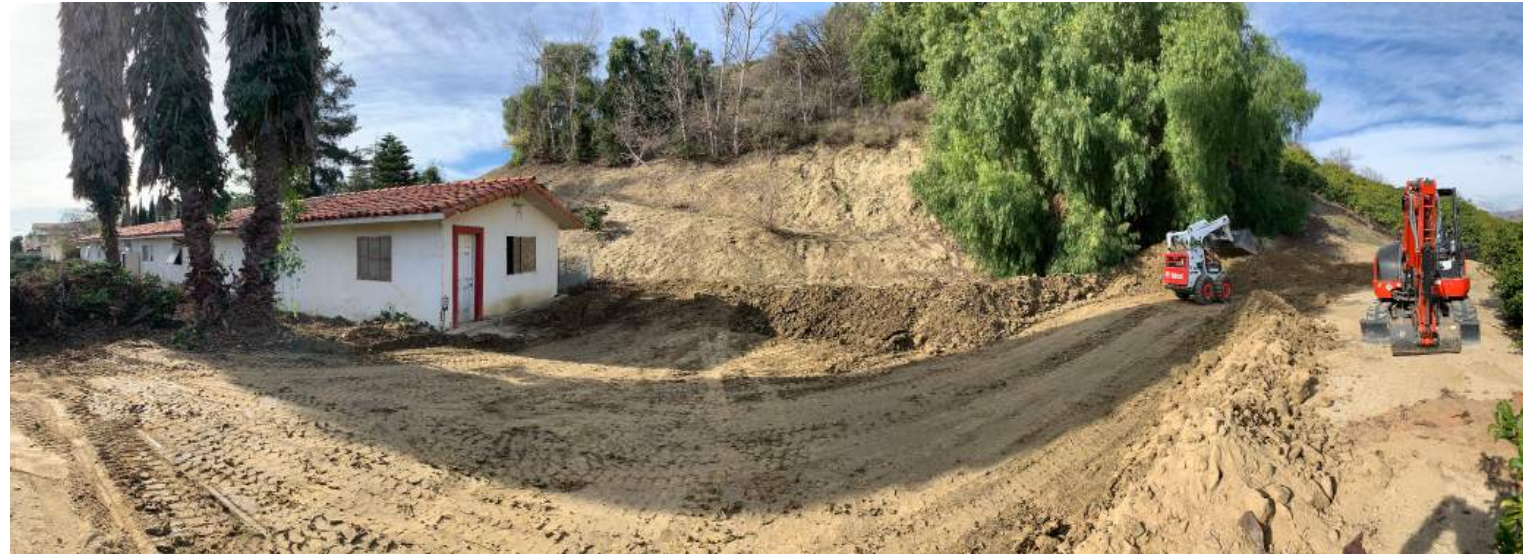
Floor Level

**Building H2**  
Exterior Damage  
Billiwhack Ranch

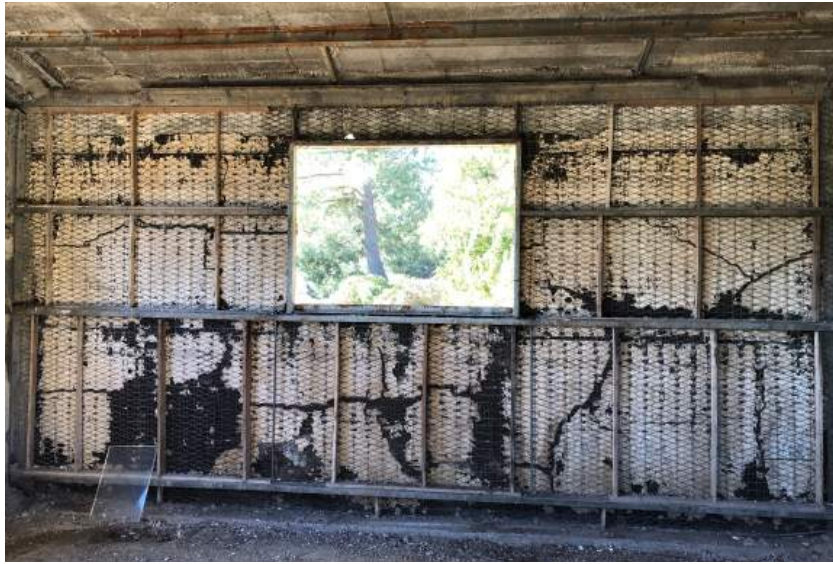
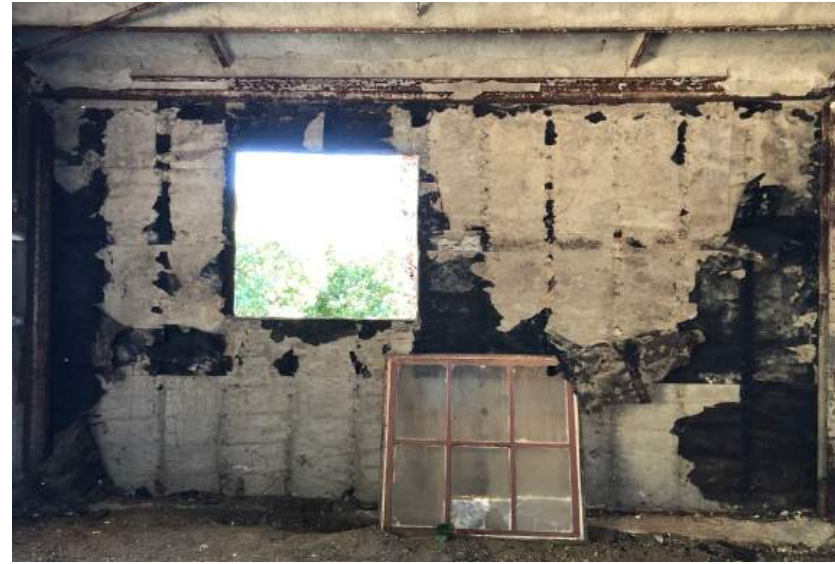
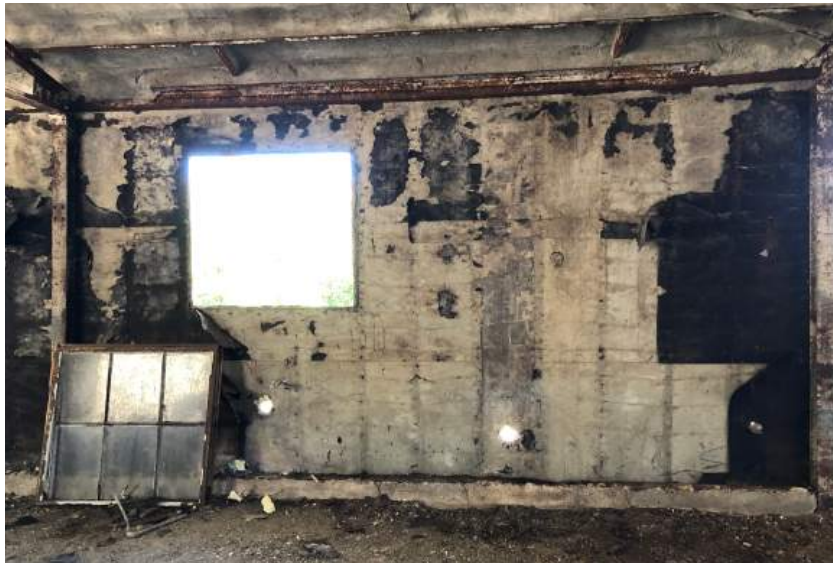
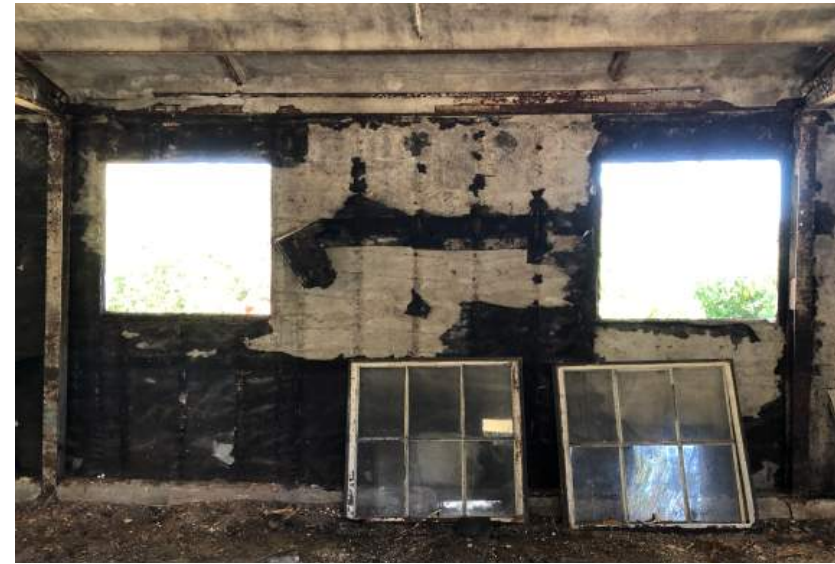
Studs and water membrane gone

Girders laid on dirt

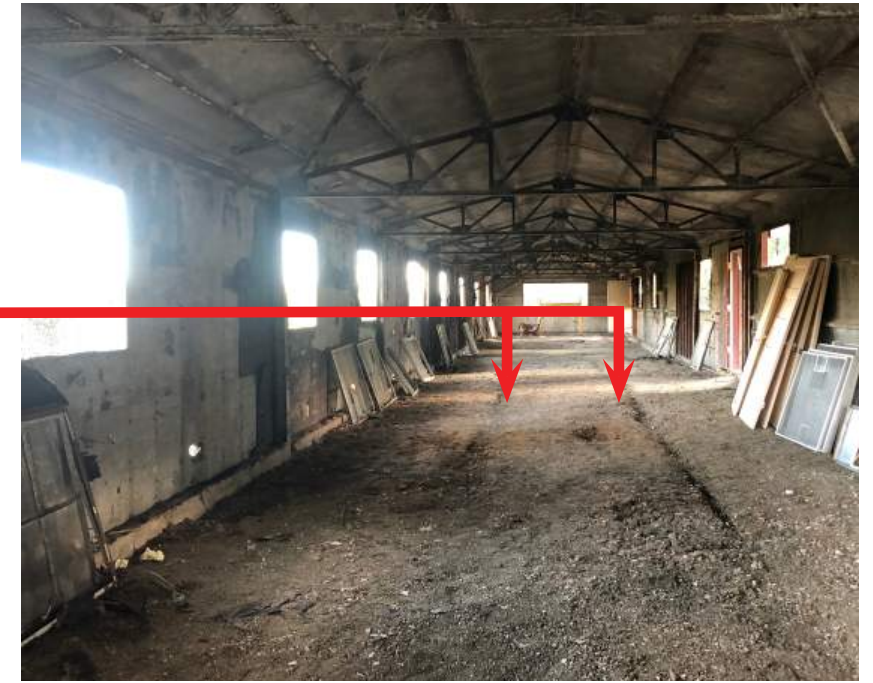
Only stucco remains

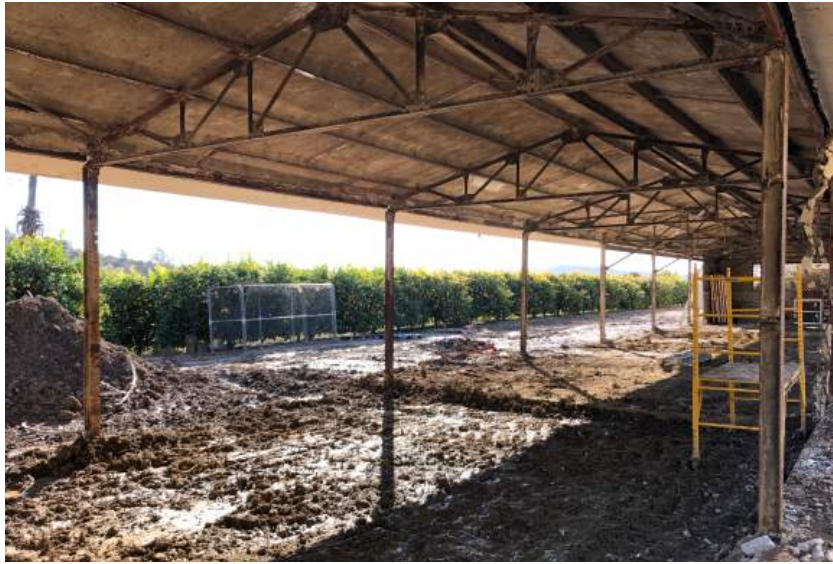
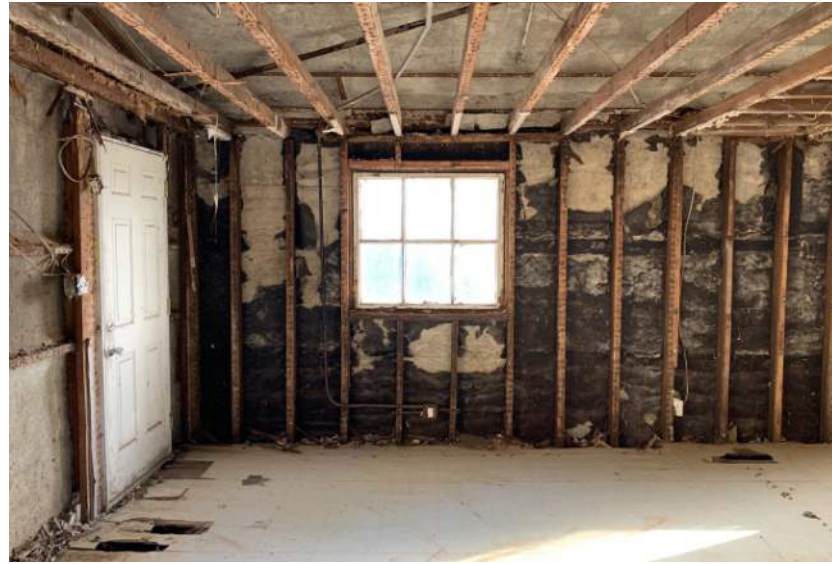
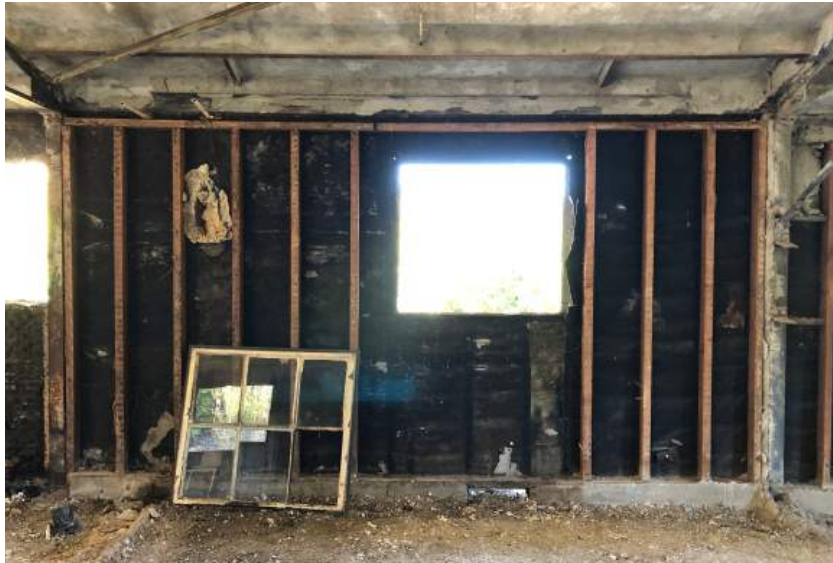
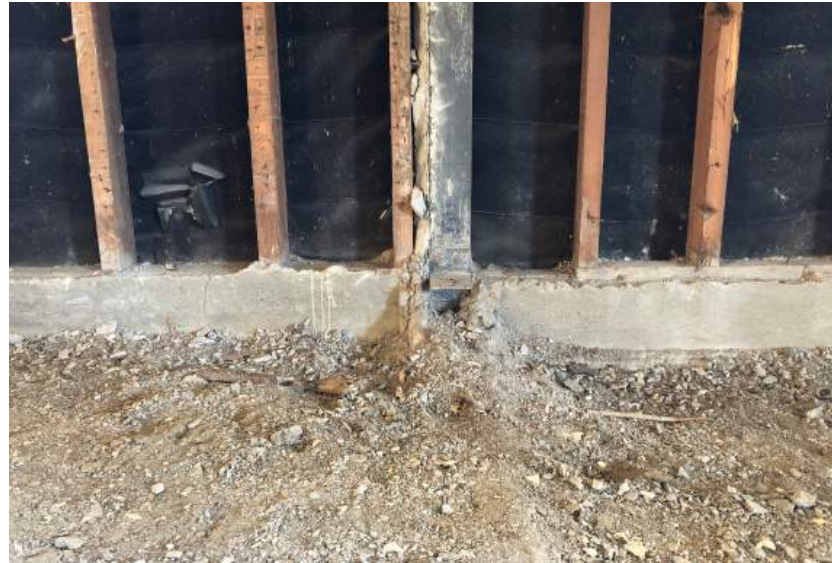
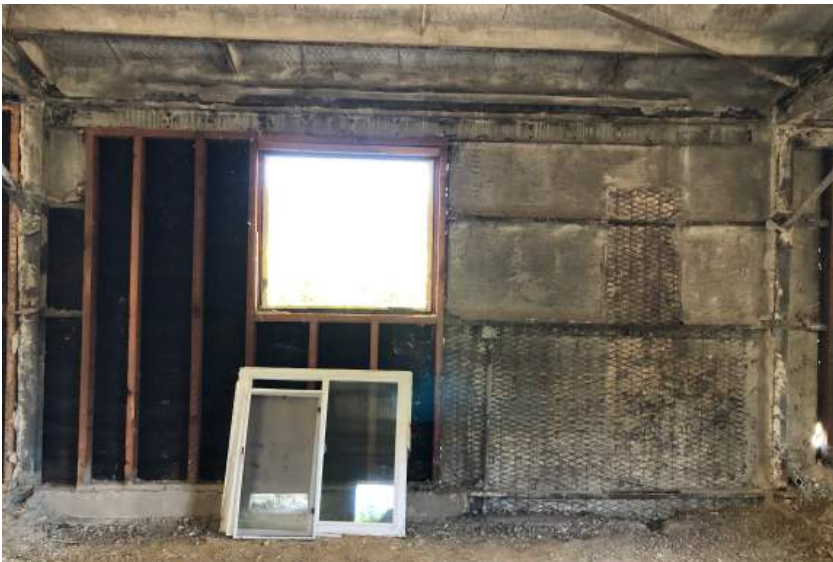
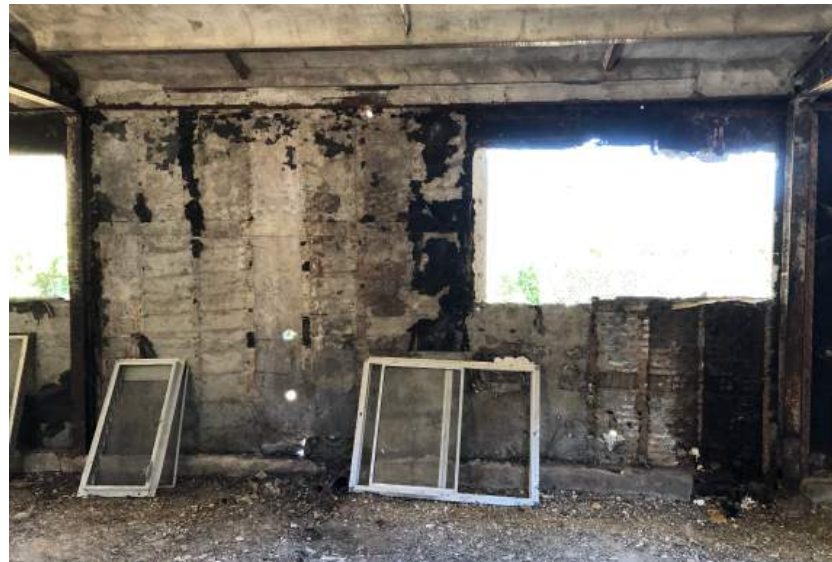
Interior Damage Pre Demo: Exposed Floors and Walls  
Billiwhack Ranch
