Appendix E

Cultural Resources Assessment

Somis Ranch Farmworker Housing Complex Project

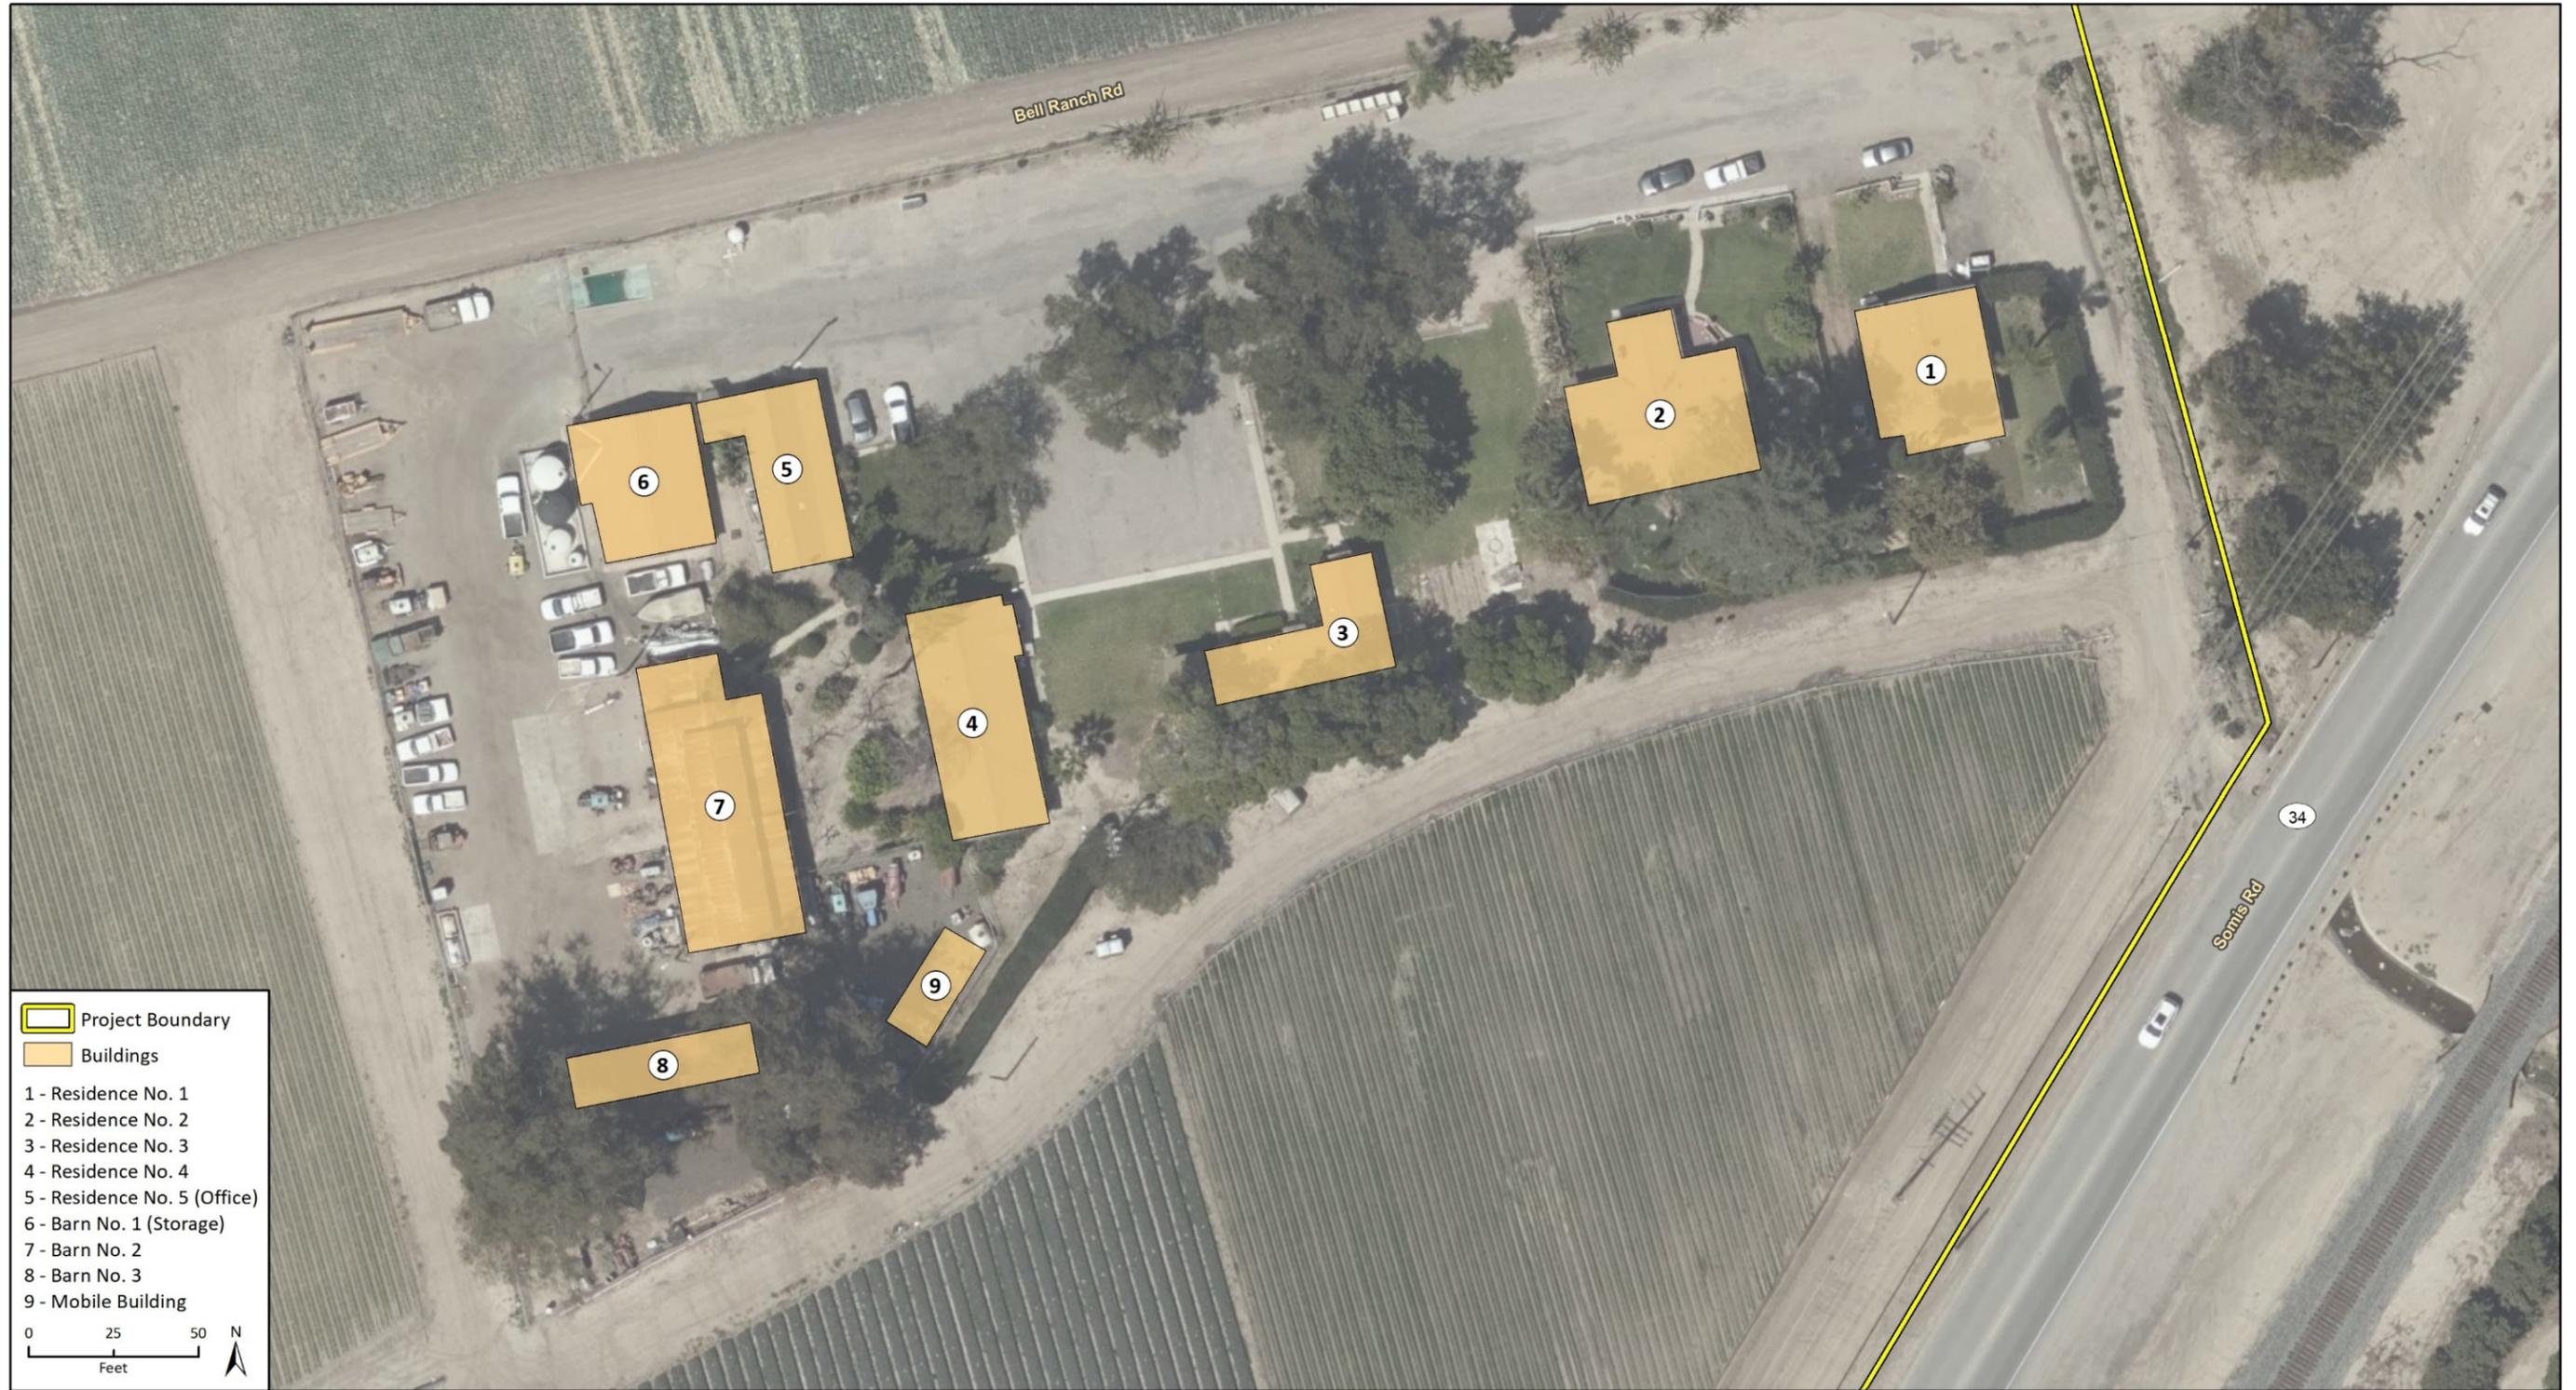
Figure 5 Site Map Identifying Buildings located on Developed Portion of the Subject Property

2789 Somis Road is an agricultural property located adjacent to and west of Somis Road, slightly north of Las Posas Road, in unincorporated Ventura County. Originally part of a much larger ranch, the property is currently 36.36 acres and includes a grouping of eight residential and support buildings at the southeast corner, otherwise surrounded by agricultural fields (Figure 5). Access is provided by an unpaved road (Bell Ranch Road) that branches off Somis Road and enters the property at east. The eight buildings are generously spaced and surrounded with mature plantings,

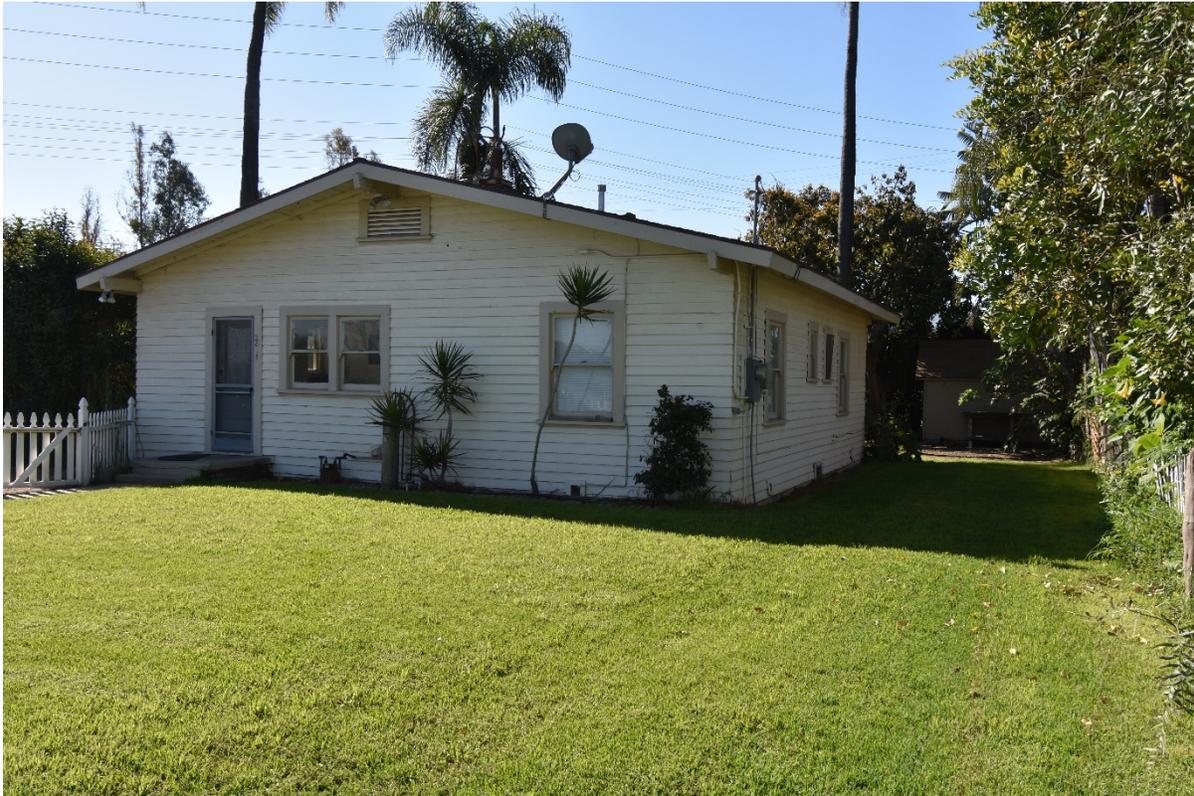
Figure 6 Residence No. 1, Primary (North) and West Elevations

The eastern-most building on the property is a single-story, rectangular-planned residence (Figure 6). The vernacular bungalow-style building sits on a concrete foundation, is clad in wooden lap siding, and exhibits original one-over-one wood sash windows of various sizes throughout. The primary entry to the building, a single, multi-panel wooden door that appears original, is offset on the north elevation. The building is topped with a low-pitched front-gabled roof with moderate overhanging eaves, which are enclosed and supported with three cantilevered exposed beams. Slatted wooden gable vents are present. A satellite dish has been mounted to the roof. Surrounding the residence inside a white picket fence is a lush lawn and mature plantings including palm and orange trees in addition to ornamentals. Although research limitations prevented definitively dating the building, based on visual observation, it appears to date to circa 1920. The building appears minimally altered and is in good condition.

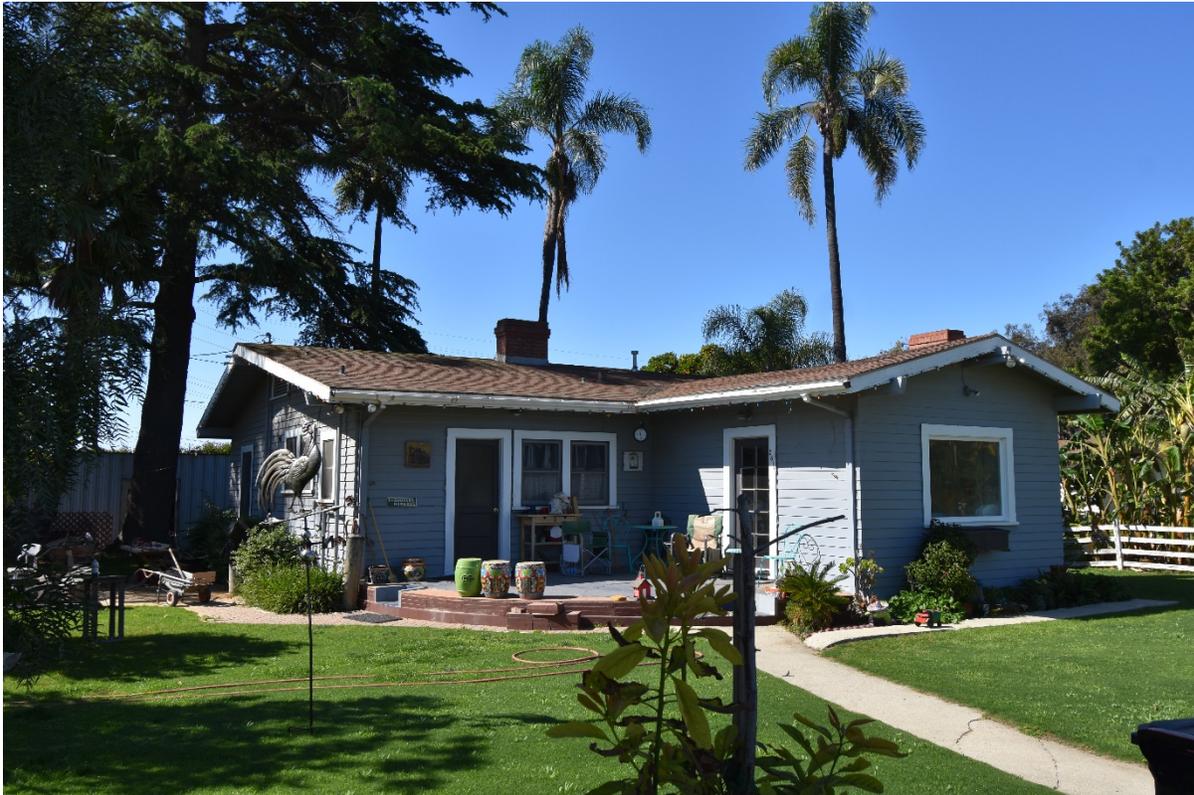
Figure 7 Residence No. 2, Primary (North) and East Elevations

Sited roughly thirty feet west of Residence No. 1 and separated by a hedge row of mature plantings, Residence No. 2 is a single-story T-planned vernacular building also built in a bungalow style (Figure 7). The building is clad in wooden lap siding and features one-over-one wood sash windows of various size throughout in addition to a single-light picture window on the primary (north) elevation, also wood-framed. Two entrances to the building, single wooden multi-light doors, are accessible via a semicircular concrete patio at the front of the building. The building is topped with a low-pitched intersecting gabled roof with moderate overhanging eaves clad in asphalt shingles. Eaves are enclosed and supported with cantilevered exposed beams. Slatted wooden gable vents are present and the building features two brick and mortar chimneys. Surrounding the building inside a wooden horizontal fence is a lush lawn and mature plantings including palm, avocado and cypress trees in addition to ornamentals. Although research limitations prevented definitively dating the building, based on visual observation, it appears to date to circa 1920. The building appears minimally altered and is in good condition.

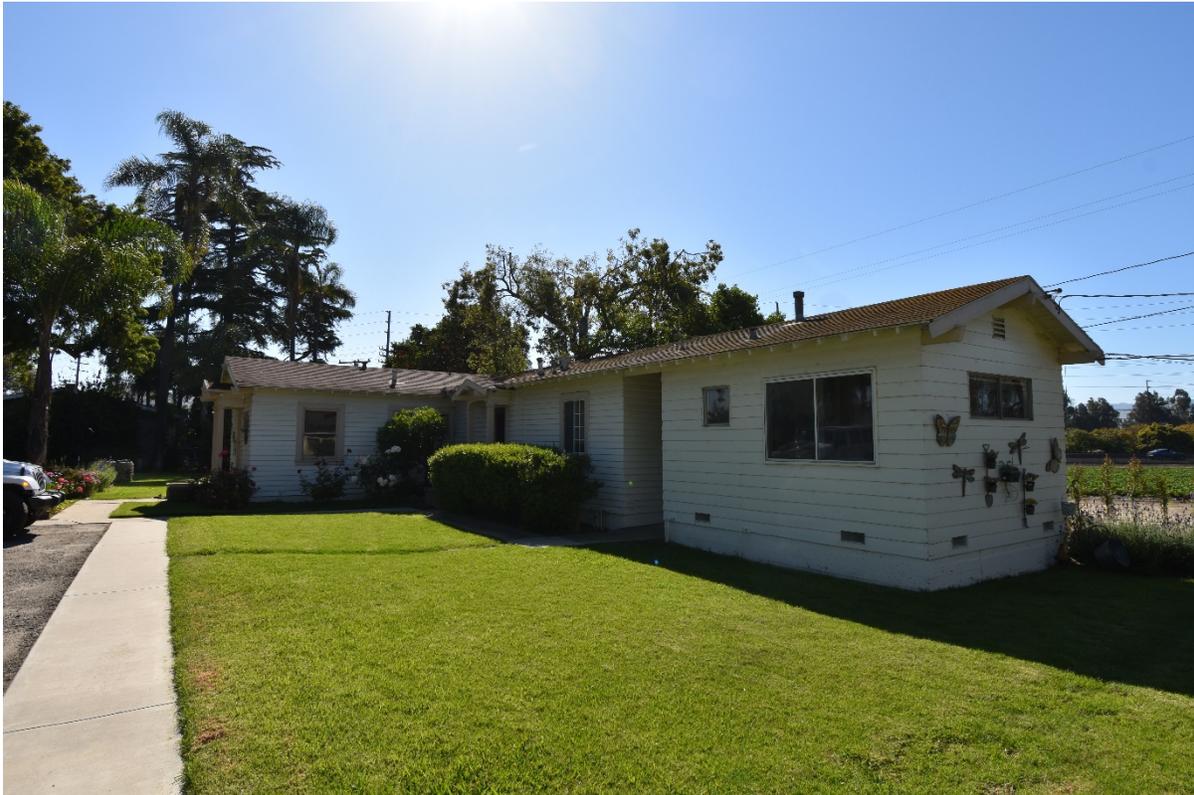
Figure 8 Residence No. 3 as Viewed from the Northwest

Sited roughly sixty feet west of Residence No. 2 and set back roughly fifty feet further south on the property, Residence No. 3 is a single-story, L-planned vernacular building built in a bungalow style (Figure 8). The building sits on a raised poured concrete perimeter foundation and is clad in wooden lap siding. Visual observation suggests its footprint was expanded westward following its initial construction, potentially more than one time. The original portion of the building features one-over-one wood sash windows, some which appear in pairs, while the apparent addition features aluminum and vinyl sliders. The building includes several entryways, two of which on the primary, north elevation are contained under gabled overhangs supported by wooden columns; these are accessible via two concrete steps.

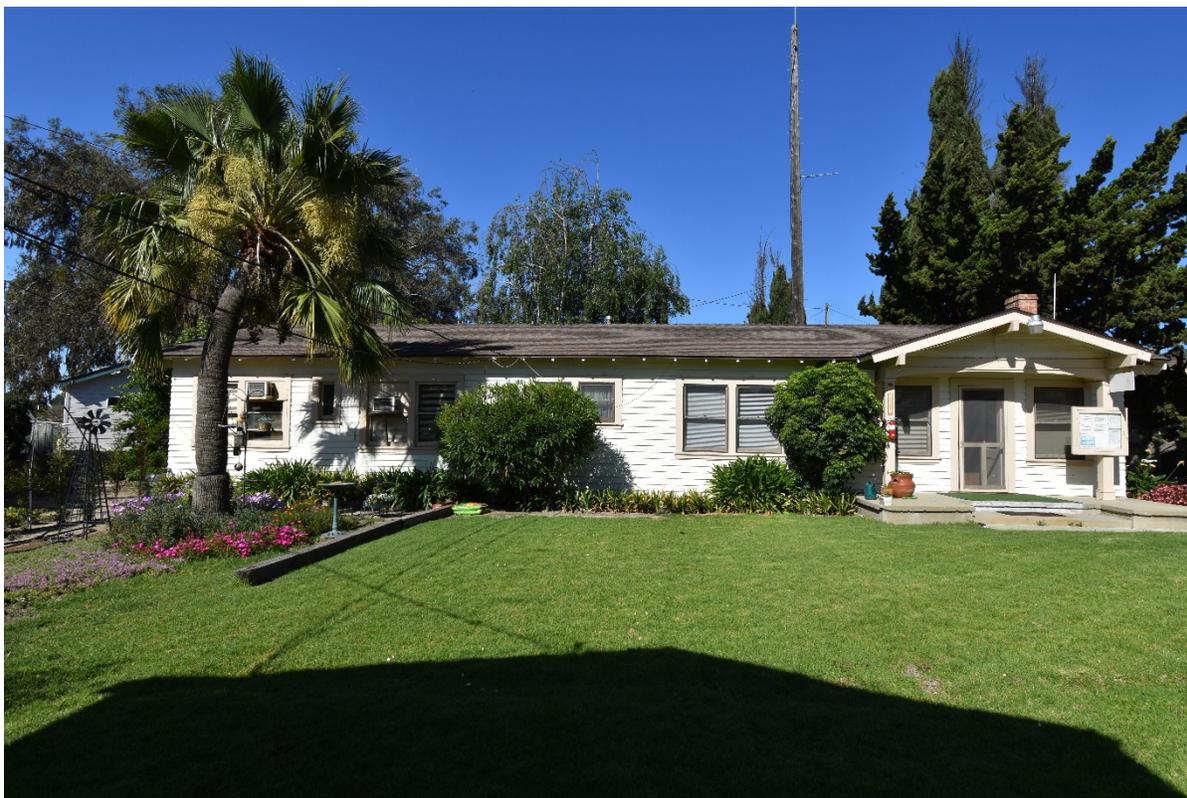
Figure 9 Residence No. 4, Primary (East) Elevation

Residence No. 4 is sited roughly 40 feet west of Residence No. 3 (Figure 9). The vernacular bungalow-style residence is a single-story and features a rectangular footprint. The building sits on a raised concrete perimeter foundation and is clad in wooden lap siding. It features one-over-one wood sash windows that appear in pairs or groupings of three. Two entrances are included, one offset (to the north) on the east elevation and another offset (to the south) on the west. Both entrances feature a single wooden door accessible via a concrete step and small porch sheltered under a gabled overhang supported with square wooden columns. The door at rear is topped with a single-light wooden transom sash; that on the primary, east elevation is bracketed with windows. The building is topped with a low-pitched, gabled roof clad in asphalt shingles. Exposed rafters and cantilevered exposed beams (decorative) support the roof. Slatted wooden gable vents are present. A brick and mortar chimney featuring a stepped design is exposed on the north elevation. The building is set back behind and surrounded by a lawn and ornamental plantings including beds of lilies. Mature cypress and orange trees surround the building at rear. Although research limitations prevented definitively dating the building, based on visual observation, it appears to have been built before 1945. The building appears minimally altered and is in good condition; it is currently being used as an office.

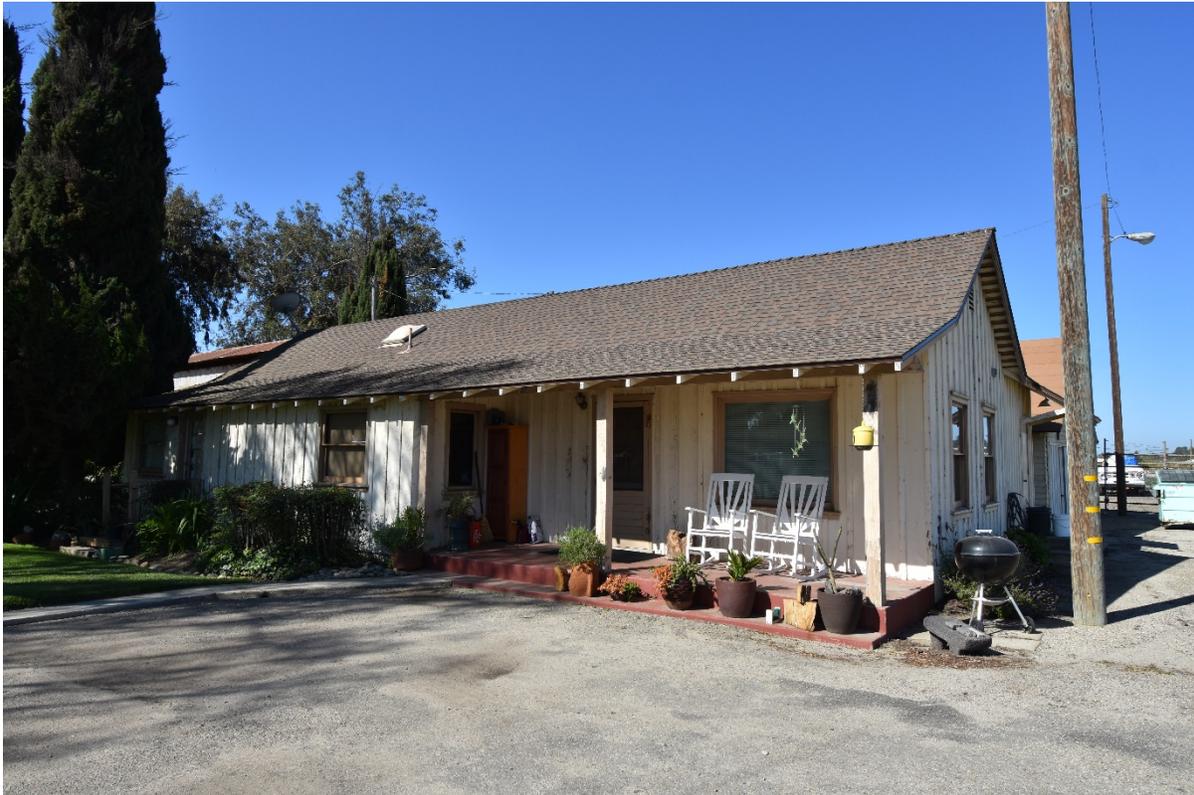
Figure 10 Residence No. 5, Primary (East) Elevation

Sited just northwest of Residence No. 4, Residence No. 5 is a single story residence exhibiting an L-shaped footprint (Figure 10). The vernacular building is clad in wooden board and batten siding and features one-over-one wood sash windows of varying size. The building is topped with an intersecting, medium-pitched gabled roof clad in asphalt shingles with exposed rafters. A partial length concrete porch sheltered under the main roof structure lines the primary, east elevation. The building's primary entry, a single wooden door covered with a wooden screen door, is accessible via the porch. The building includes two secondary entrances on the north and west elevations, both accessible via steps and a concrete stoop. The door on the north elevation appears non-original while all other doors and windows appear original. The building is surrounded with mature vegetation, including cypress trees and rose bushes, to its south and west. Although research limitations prevented definitively dating the building, based on visual observation, it appears to predate the Residence Nos. 1 and 2 and is estimated to have been built earlier in the twentieth century. It appears minimally altered and is in good condition.

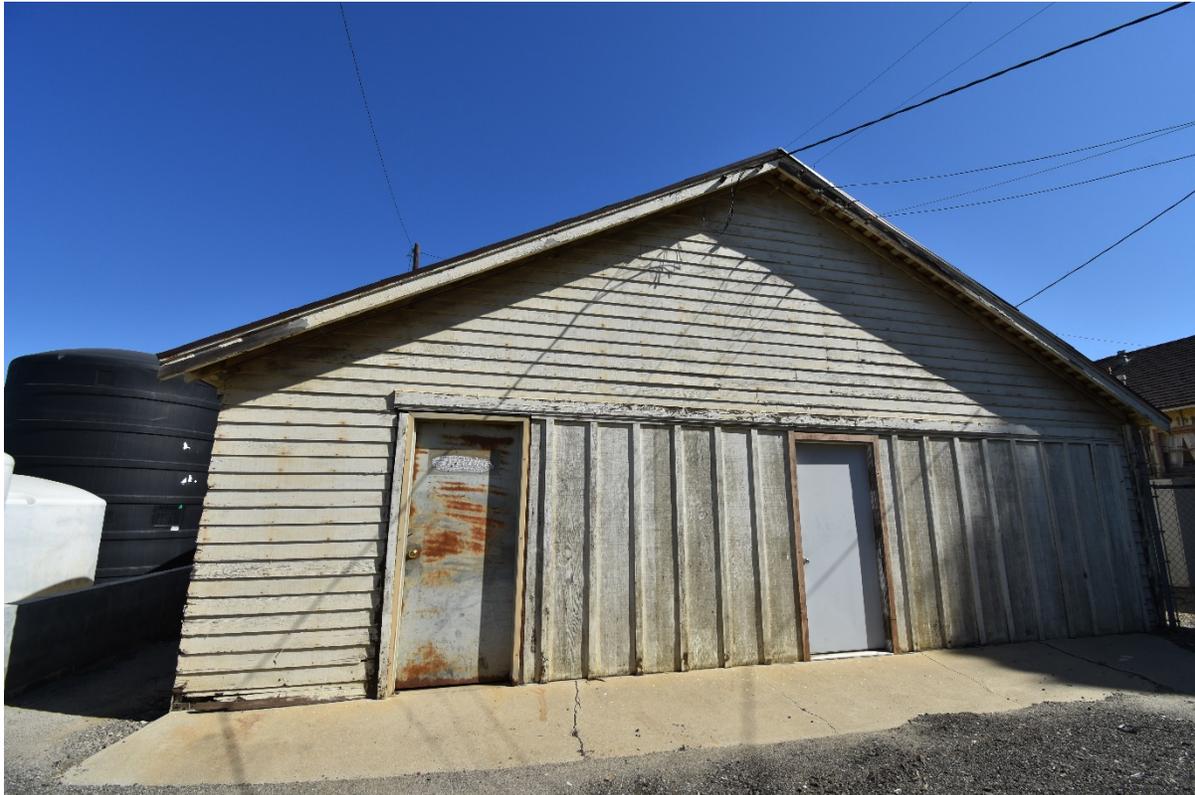
Figure 11 Barn No. 1, South Elevation

Barn No. 1 is a single-story, rectangular-planned utilitarian building sited adjacent to the west of Residence No. 4 (Figure 11). The building is topped with a gabled roof with moderate overhangs and exposed rafters clad in rolled asphalt. It is clad in wooden lap siding and exhibits no window openings. Original barn doors on the north and south elevations have been removed and their large openings infilled with a combination of board and batten siding and solid, contemporary doors (two on each elevation). A small shed-like addition has been added to the building's northwest corner to provide covered storage. Compared with property residences, the building is surrounded with minimal vegetation. Although research limitations prevented definitively dating the building it appears to date to have been built before 1945. It appears relatively intact and in fair condition; it is currently used for storage.

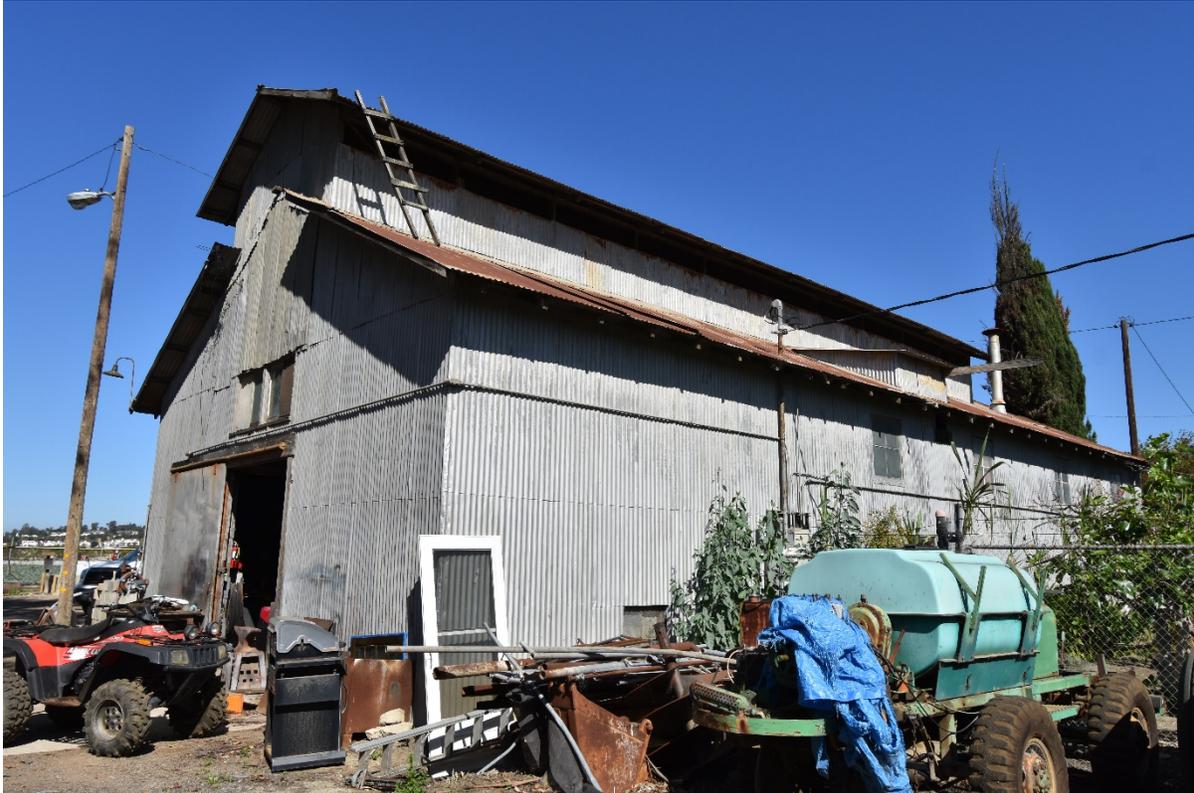
Figure 12 Barn No. 2, East and South Elevations

Located roughly 25 feet south of Barn No. 1, Barn No. 2 is a monitor barn with an apparent addition on the north end, creating roughly a L-shaped plan (Figure 12). It is clad in corrugated vertical metal paneling. The building is topped with a gabled clerestory roof clad in corrugated metal paneling consistent with siding material. It exhibits limited window openings; those extant throughout are relatively small and include various types of metal window sash. Large door openings are featured on the south and west elevations of the building. An original sliding metal-clad barn door remains extant on the south elevation door opening; the door on the west elevation appears to be non-original. Compared with the property's residences, the building is surrounded with minimal vegetation. Although research limitations prevented definitively dating the building it appears to date to have been built before 1945. The building appears relatively intact and in fair condition; it is currently used as a workshop.

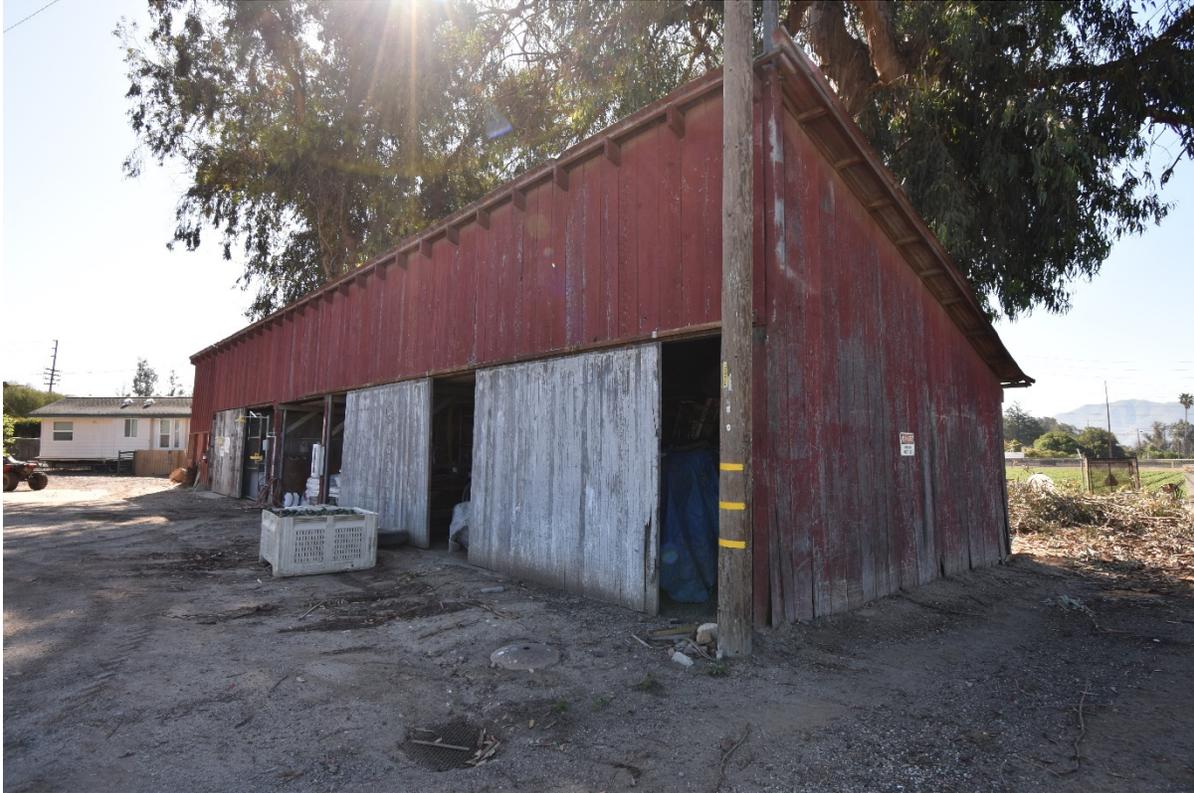
Figure 13 Barn No. 3, Primary (North) and West Elevations

Barn No. 3 is located roughly 20 feet south of and sited trending west-east to face Barn No. 2 (Figure 13). The utilitarian building is a single-story and features a rectangular footprint. It is clad in vertical wooden siding (some areas are board-and-batten), painted red. The building is topped with an exaggerated shed roof clad in corrugated metal paneling with minimal overhang and exposed rafters. Minimal window openings are included but the primary (north) elevation is lined with large openings covered with wooden sliding barn doors that appear original. It is surrounded with minimal vegetation although two large eucalyptus trees are extant to its immediate rear (south). Although research limitations prevented definitively dating the building it appears to date to have been built before 1945. The building appears minimally altered and is in fair condition; it is currently used for storage.

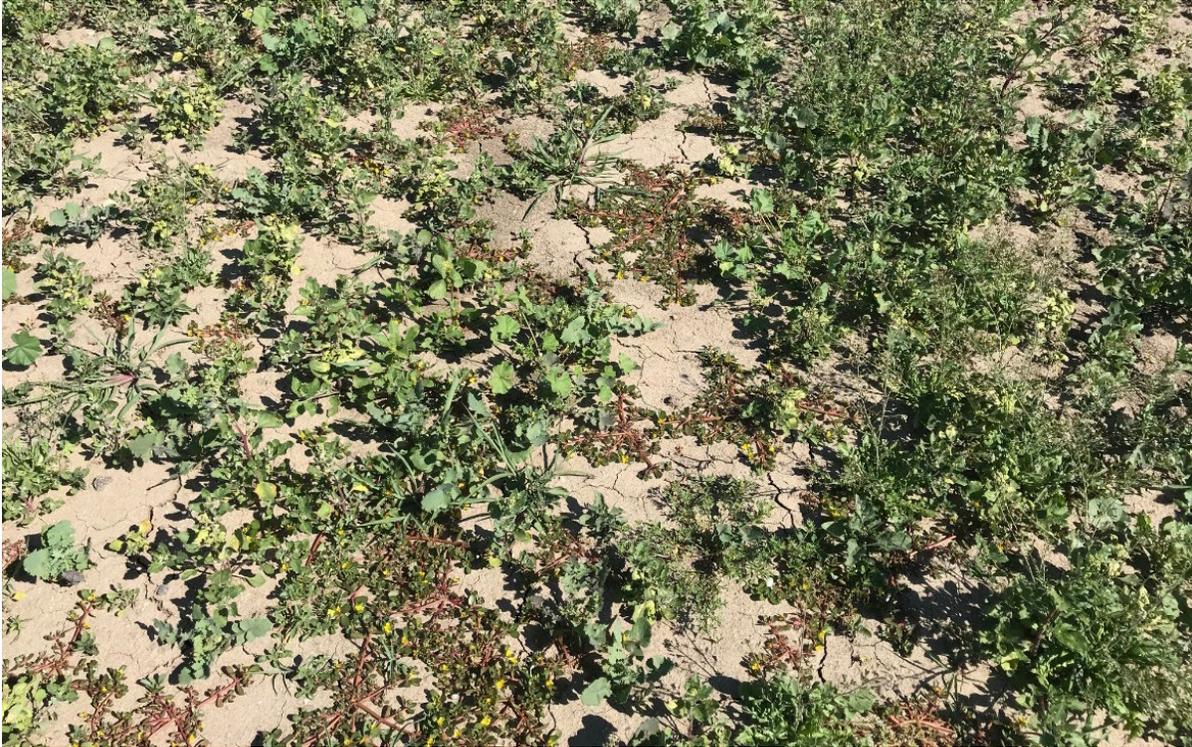
Figure 17 Exposed Soil Within Project Site

Overall ground visibility was less than five percent with 100 percent exposure. Exposed soil was a light to medium brown very fine-grained well drained silty sand with igneous pebbles intermixed (Figure 15). Vegetation consisted primarily of agricultural crops including strawberries, celery and cabbage and seasonal non-native grasses. The cabbage and celery fields were not able to be surveyed due to zero ground visibility within those areas of the project site (Figure 16, Figure 17). Three heavily calcified shell fragments were observed along an unnamed dirt access road within the southern portion of the project site (Figure 18, Figure 19); no cultural materials or soil discoloration were observed in association with the shell fragments. Along the eastern project site boundary, a north to south trending access road is situated adjacent to a historic-period culvert (Figure 20). Clam shell, modern refuse, historic-period manganese dioxide decolorized glass fragments (amethyst glass, ca. 1870-1920), ceramic sherds and undiagnostic glass fragments were observed on either side of the culvert (Figure 21, Figure 22 and Figure 23). Because the refuse was intermixed with modern refuse, it was not recorded as an archaeological site.

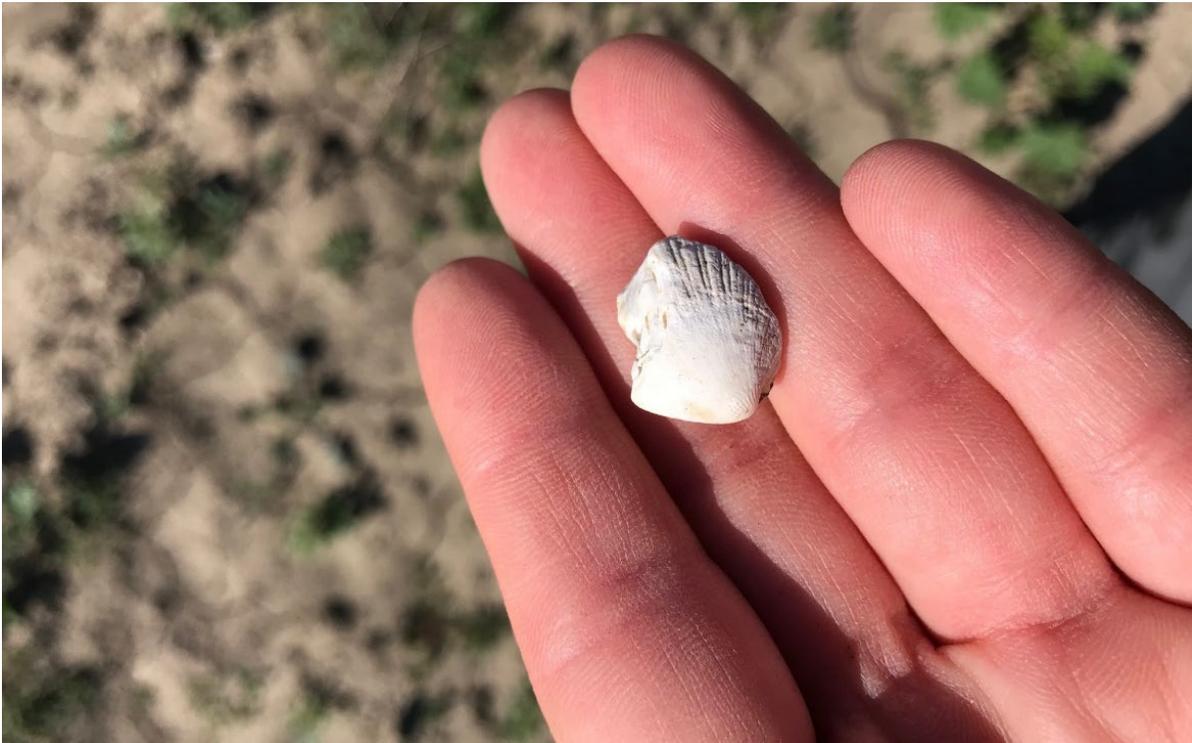
Figure 20 Shell Fragment Within Southern Portion of Project Site

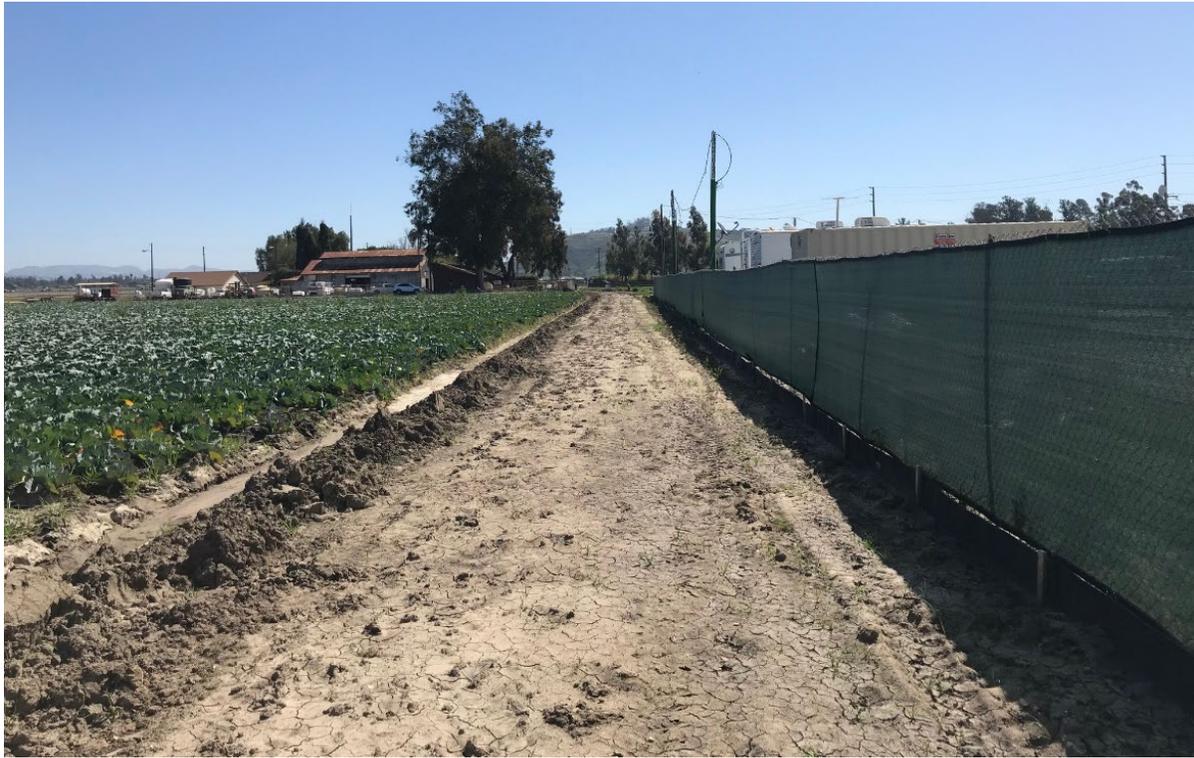
Figure 21 Overview of Shell Fragments Along Access Road, Facing East/Northeast

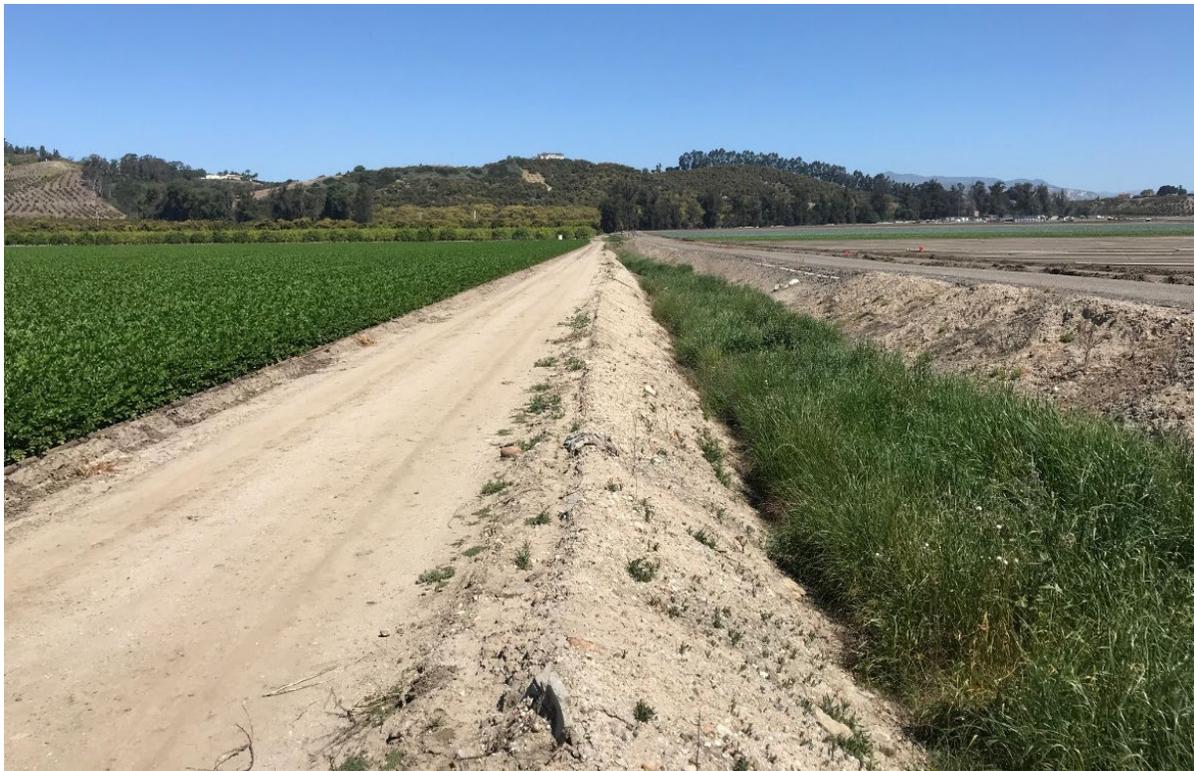
Figure 22 Historic-Period Culvert, Facing North

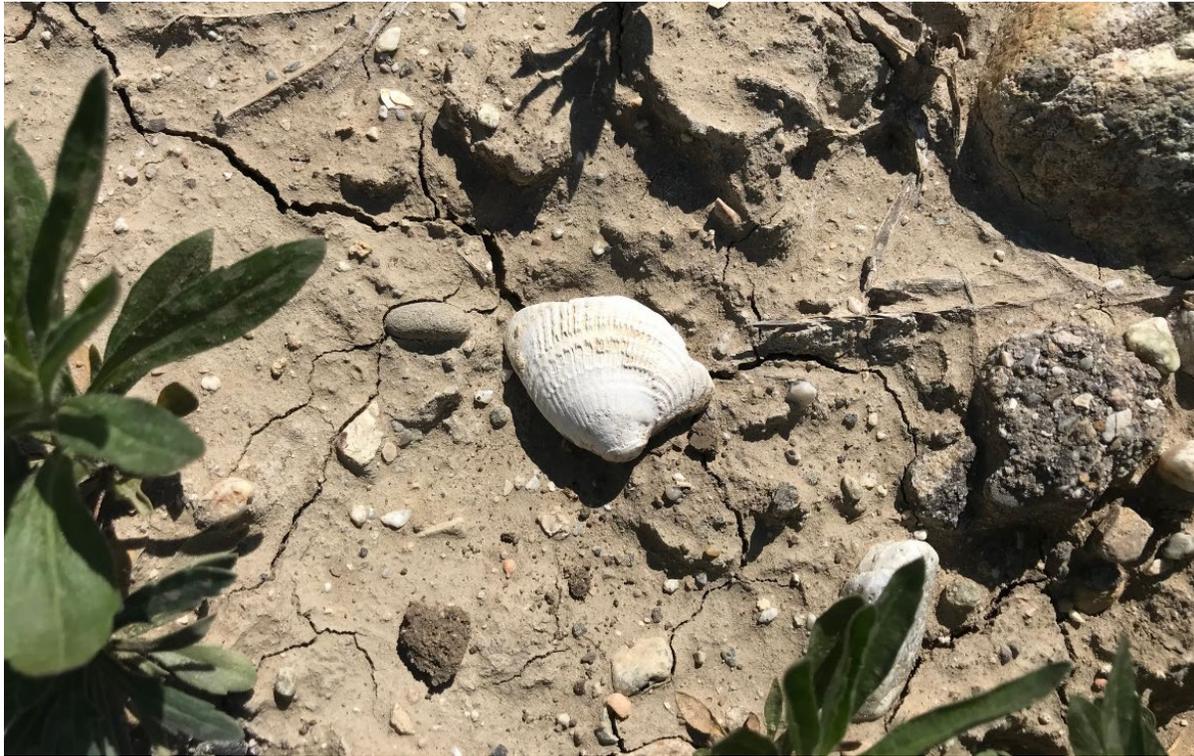
Figure 23 Shell Located Along Historic-Period Culvert

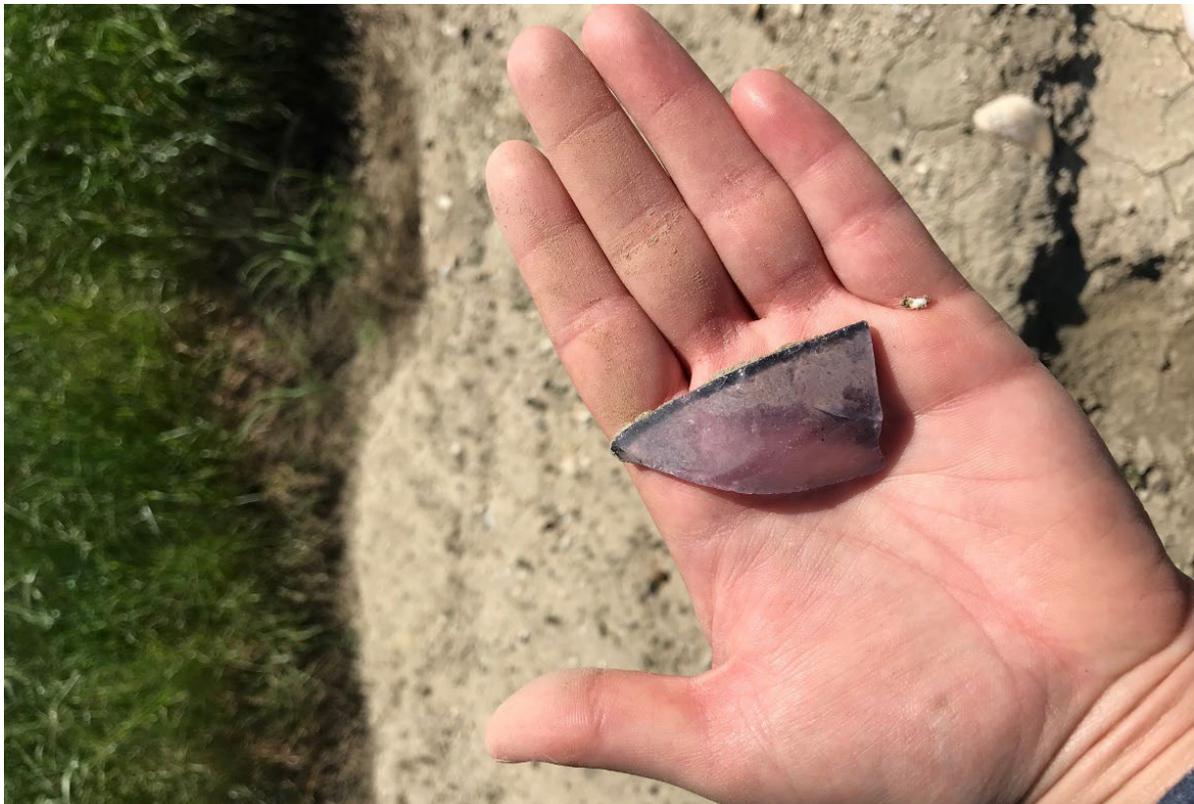
Figure 24 Amethyst Glass Fragment Located Along Historic-Period Culvert

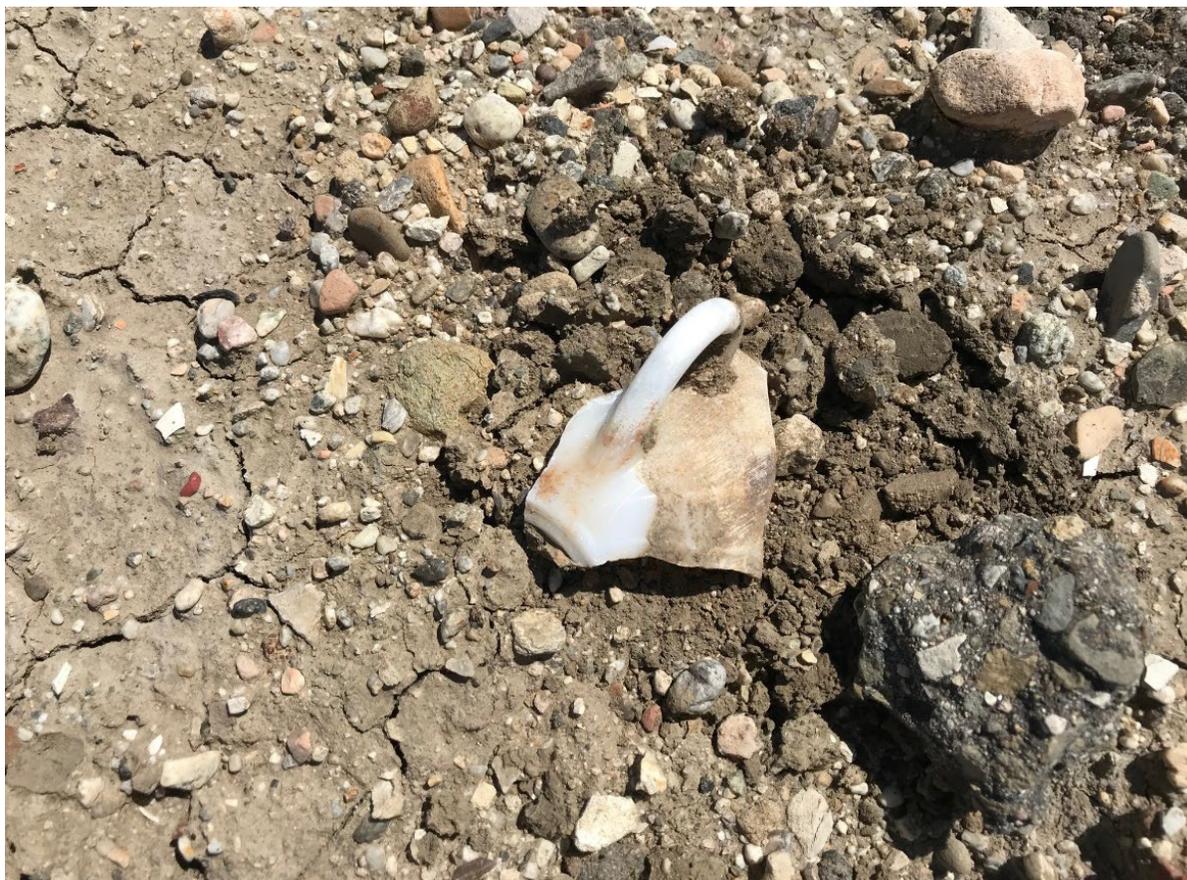
Figure 25 Ceramic Fragment Located Along Historic-Period Culvert

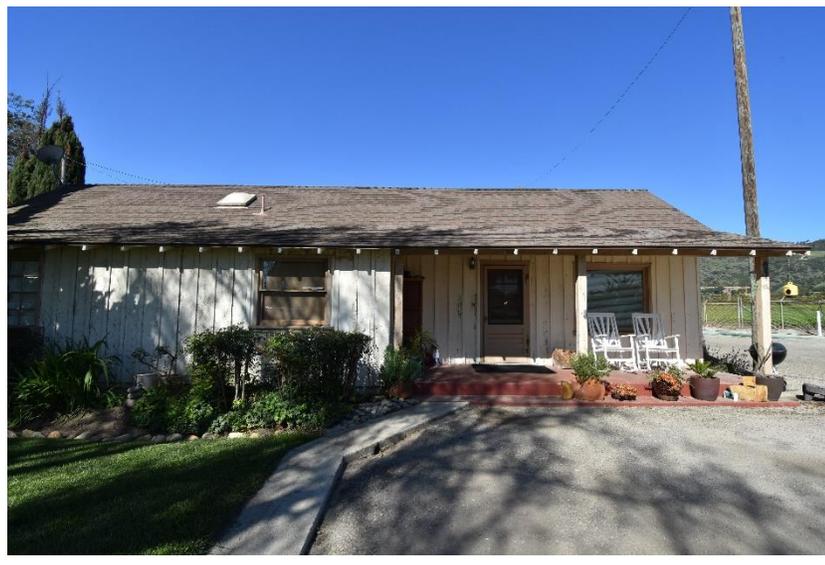
P5a. Photo or Drawing

Residence No. 5, view facing west, April 30, 2020.

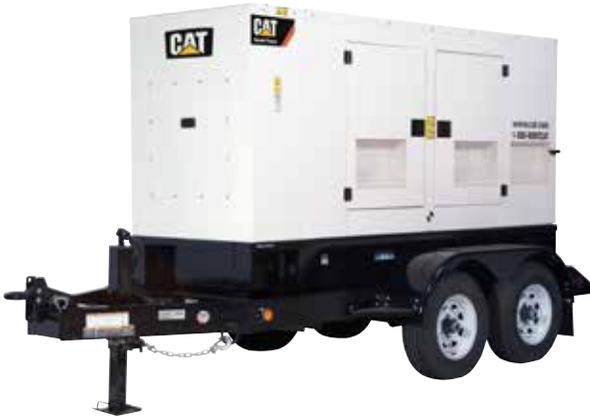
STANDBY 200 kW PRIME 182 kW POWER MODULE

Frequency	Voltage	Standby kW (kVA)	Prime kW (kVA)
60 Hz	600V	200 (250)	182 (227.5)
60 Hz	480/277V	200 (250)	182 (227.5)
60 Hz	240/139V	200 (250)	182 (227.5)
60 Hz	208/120V	200 (250)	182 (227.5)

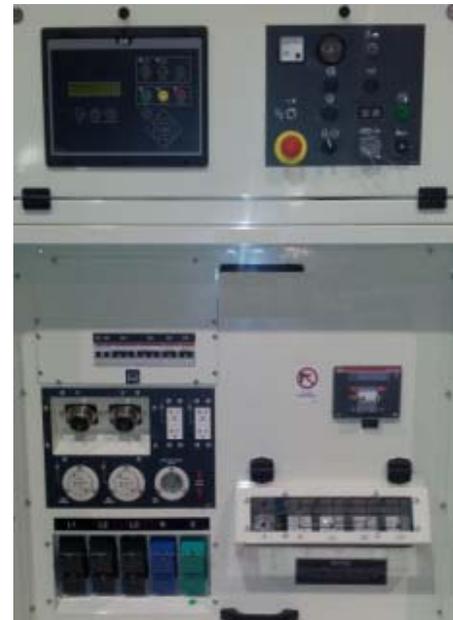
EMCP 4.2 GENERATOR PROTECTIVE RELAYING

- Generator protective features provided by EMCP 4.2
 - Phase over/under voltage (Device 27/59)
 - Over/Under frequency (Device 81 O/U)
 - Reverse Power (Device 32/32RV)
 - Current Balance (46)
 - Overcurrent (Device 50/51) (GCB trip unit)
 - Loss of Excitation (Device 40) (CDVR)
 - Generator Phase Sequence

DISTRIBUTION PANEL

- One 4 pole 800 A MCCB, with 12 VDC shunt trip coil activated on any monitored engine or electrical
- Under-voltage release NEMA 1 steel enclosure with hinged lockable door with clear Plexiglas window
- Bus bars are sized for full load capacity of the generator set at 0.8 power factor.
- Includes ground bus, tin-plated copper, for connection to the generator frame ground and field ground cable.
- Customer convenience panel with multiple output receptacles:
 - 1 – 125V, 30 A single phase auxiliary supply
 - 2 – 240V, 50A California style Twist Lock.
 - 2 – 120/208V, 20A Twist Lock.
 - 2 – 120V, 20A Duplex Receptacles with GFI..
- CamLock distribution system
- Consistent 120VAC output from GFCI receptacles independent of bus bar voltage
