County of Ventura  
July 22, 2024  
Cultural Heritage Board Meeting  
Item 6a  
Exhibit 2 – Before Photographs

Billiwhack Ranch

## Building H2

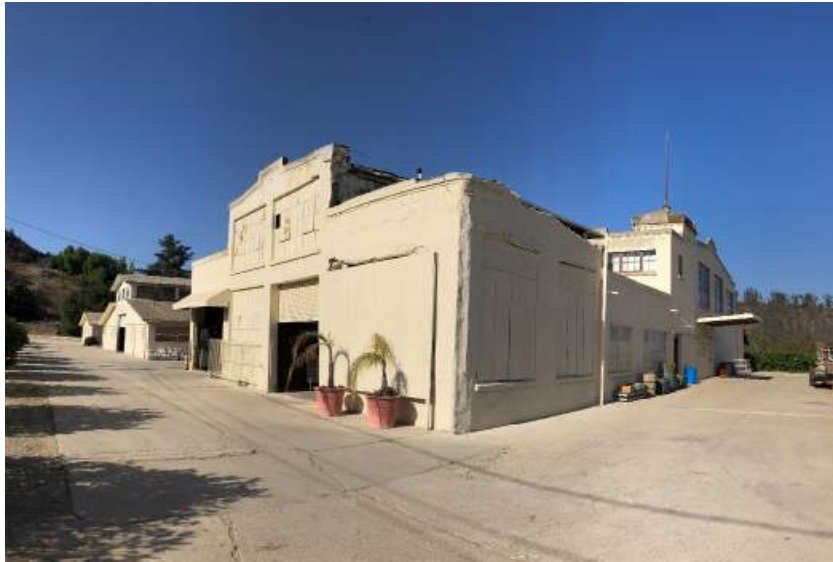
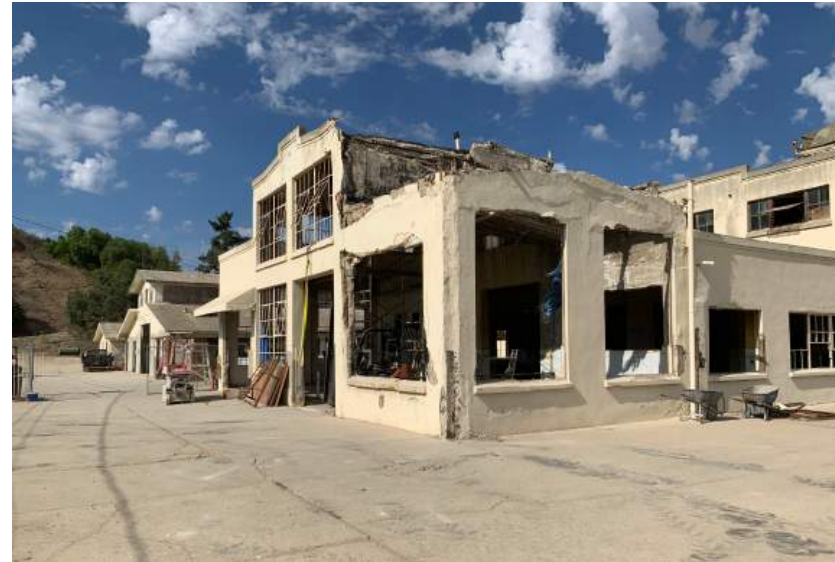
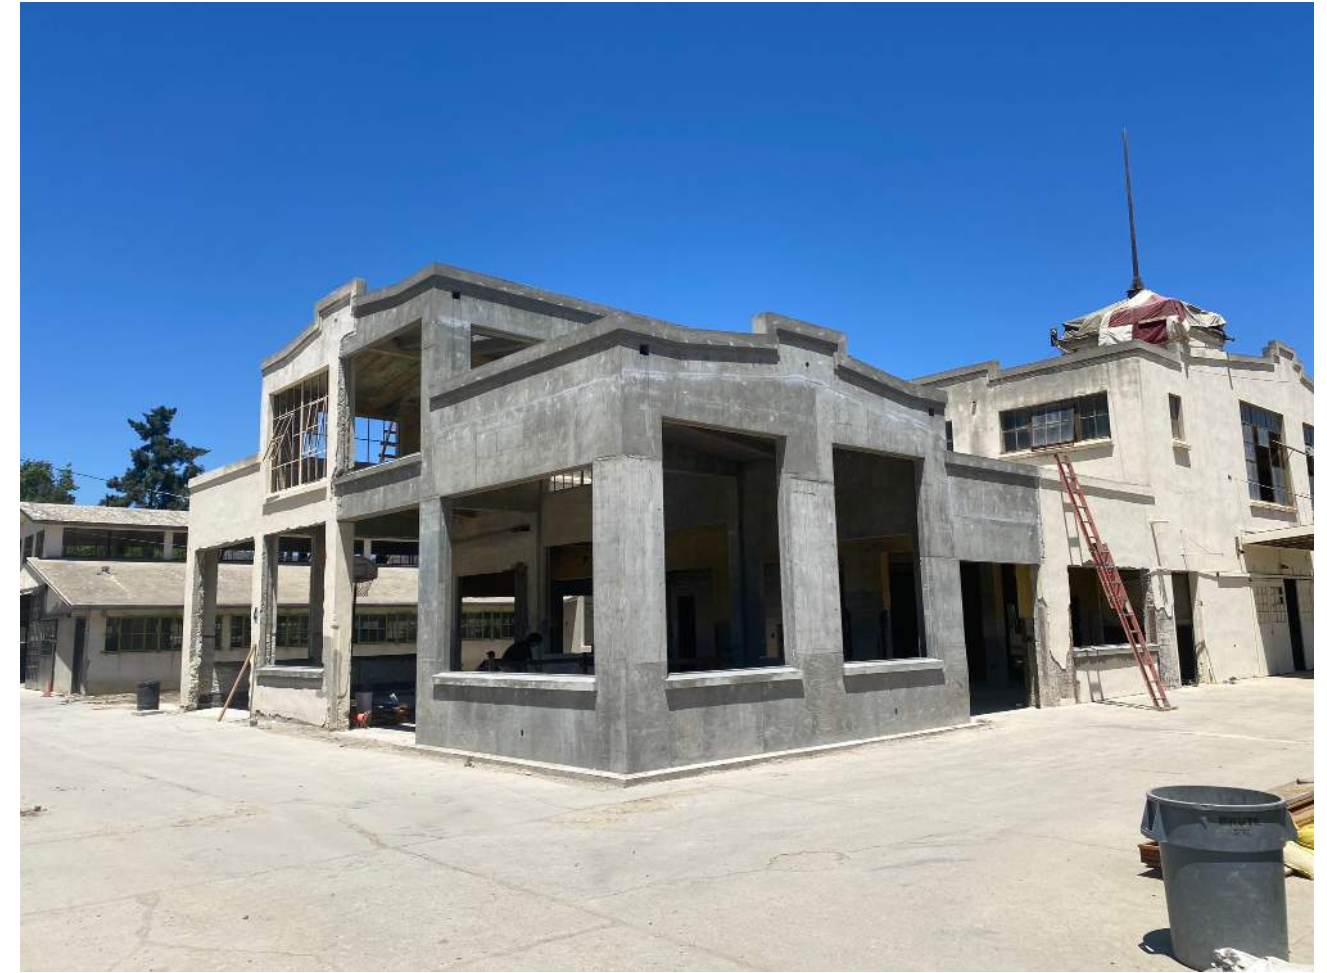
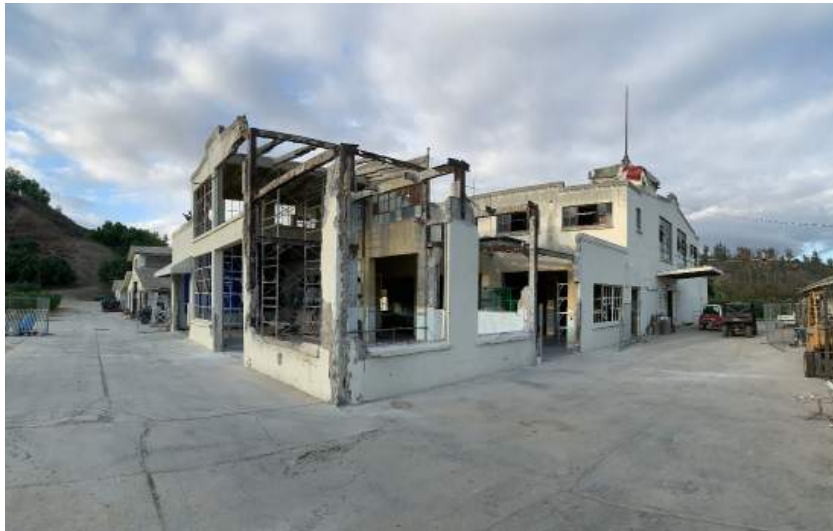
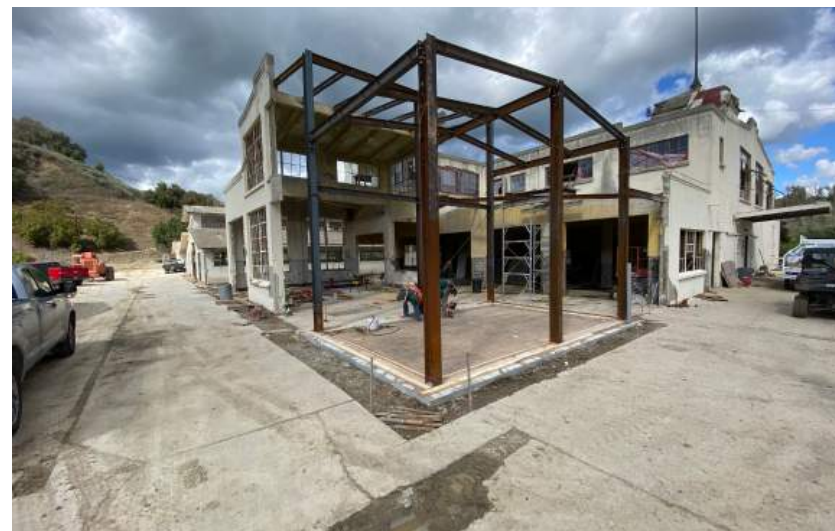
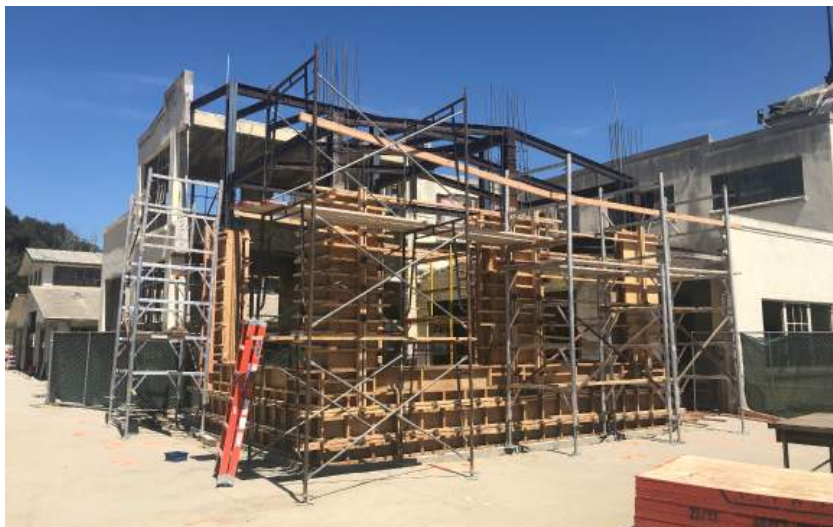
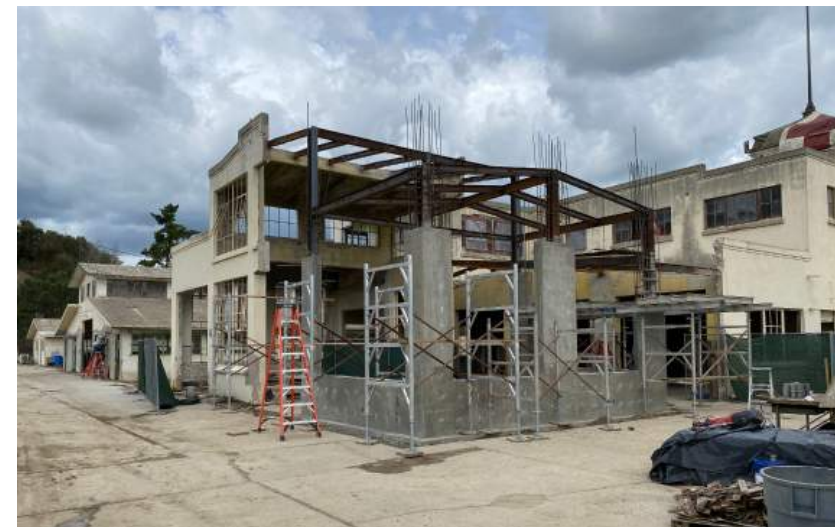
We were granted a repair permit for a residence that has allowed us to repair the front corner of the Creamery building (see photos next page). We have spent approximately \$750,000 on an historically accurate repair, in both materials and construction methods. We believe the integrity that has been exhibited during this repair should define our commitment to rehabbing all of the buildings with care and consideration.

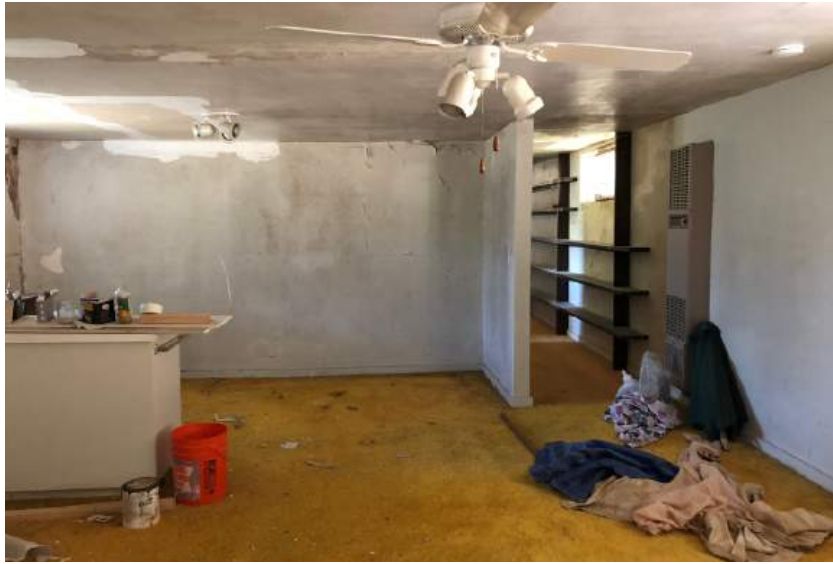
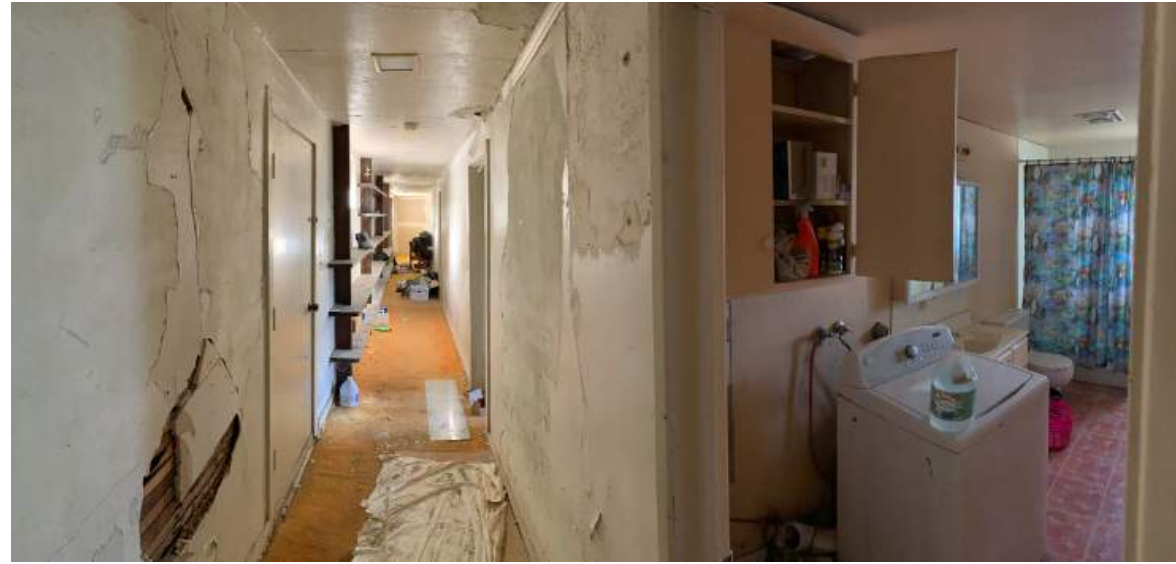
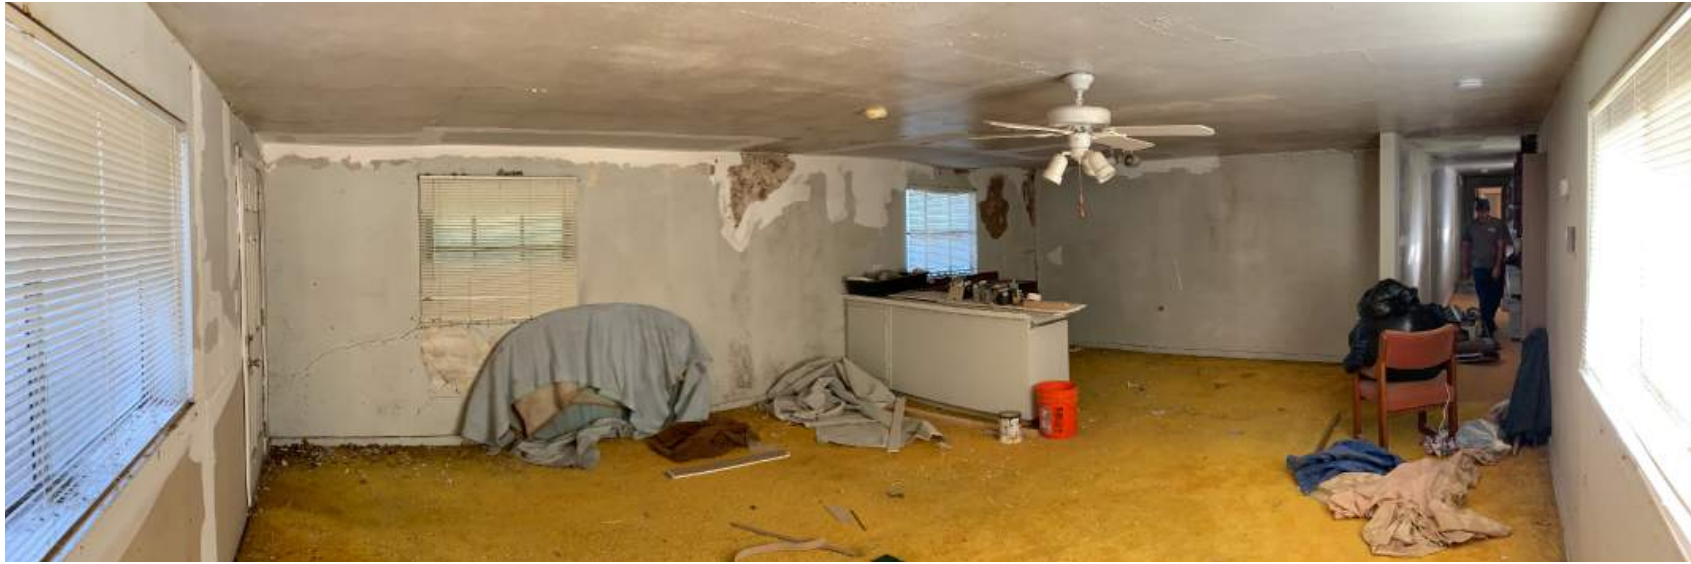
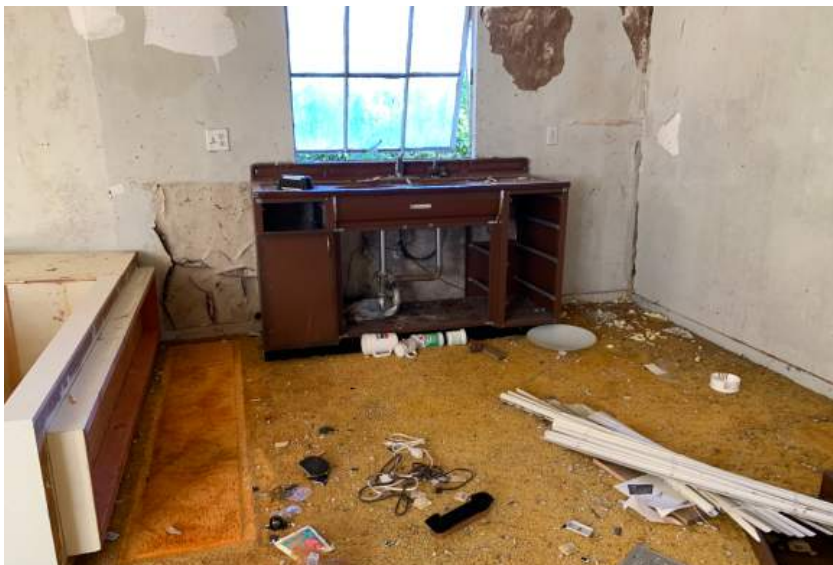
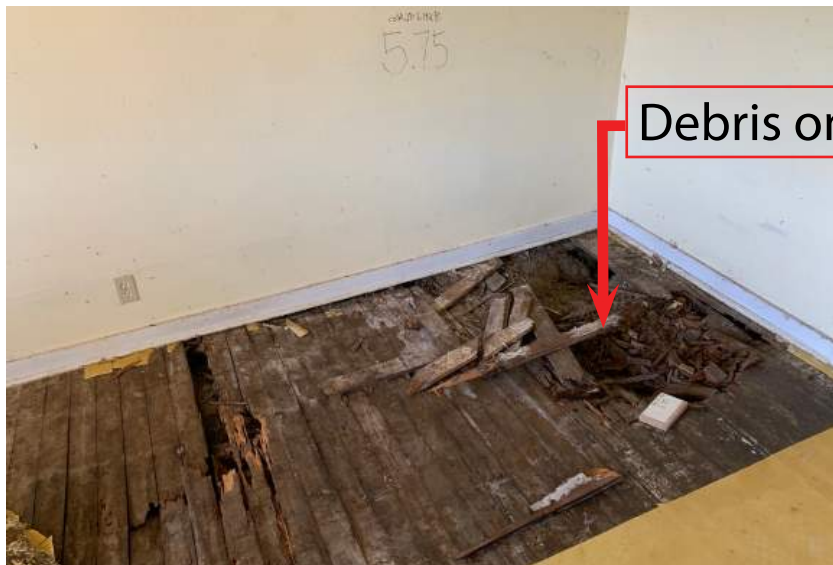
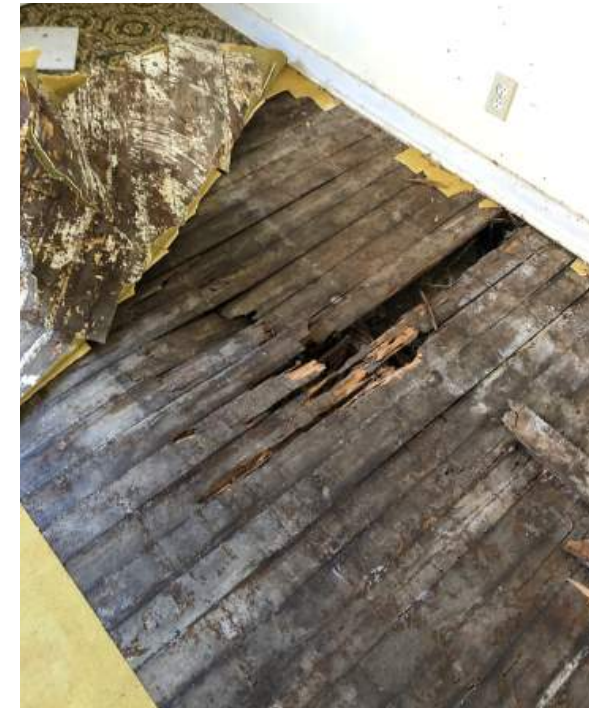
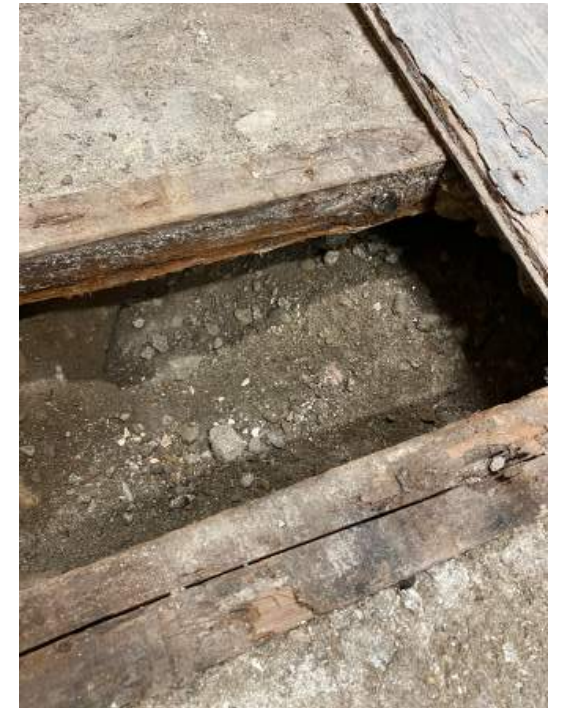
The issue we are faced with, and the reason for this meeting, is the characterization of building H2's damaged area as voluntary. Building H2 is a 2,400 sf historic residence that had extreme deferred maintenance when we purchased the property. Our plan was to perform some initial, surgical investigation to determine the work that was needed to do a light remodel.

The combination of poor design and execution, along with 50 years of deferred maintenance and mud flows from the adjacent hill plus the riding arena, directed water towards the building. The grade crept up through the years and, in the end, was higher than the wood framed floor & walls. Water had been wicking into and up the stucco for years. The studs were rotted out and some completely gone. All the original lathe paper was gone. The floor, just inches above the dirt, was spongy and one could step through it in places. What began as a surgical investigation to determine the scope of work turned into a removal of all of the damaged, non-structural infill and finishes. The original steel structure remains intact and roof tiles were saved.

Interior Damage Pre Demo: Floor, Walls, Ceiling (Exposed Damage)  
Billiwhack Ranch

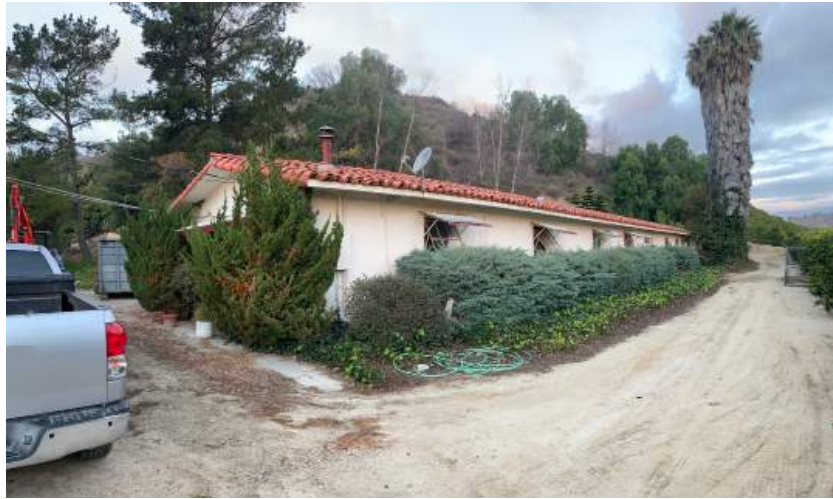
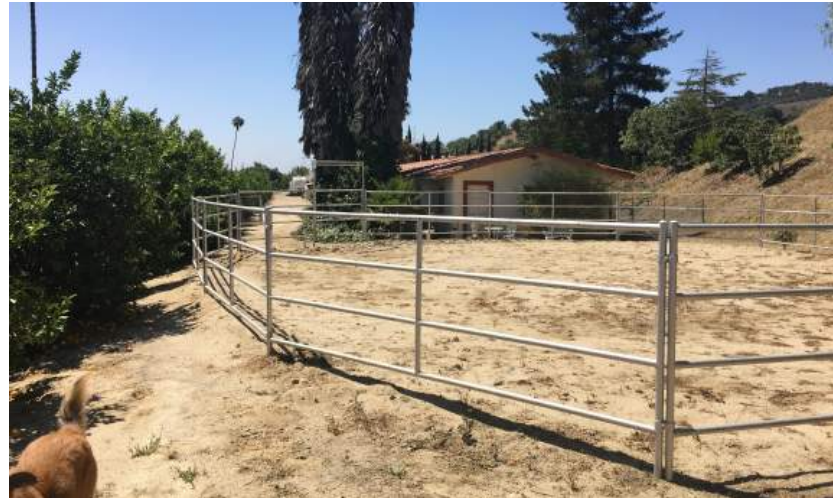
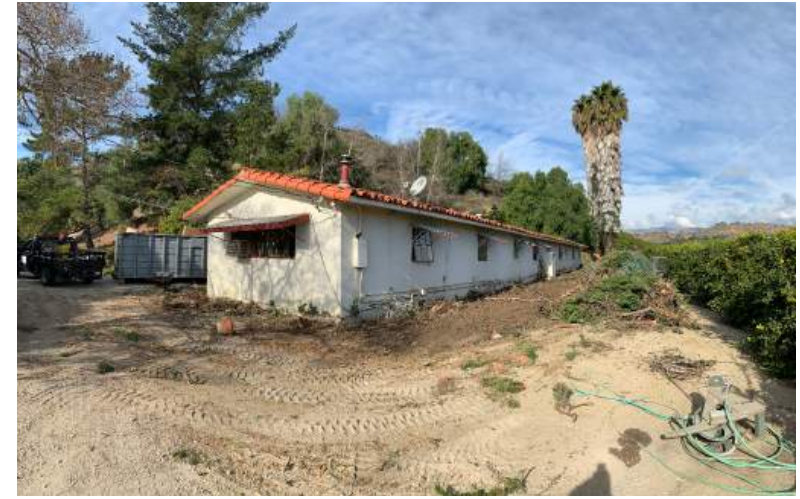
## Building H2

Interior Damage Pre Demo: Floor, Walls, Ceiling (Exposed Damage)  
Billiwhack Ranch

South Side:  
Stress fractures & damage  
visible at each window

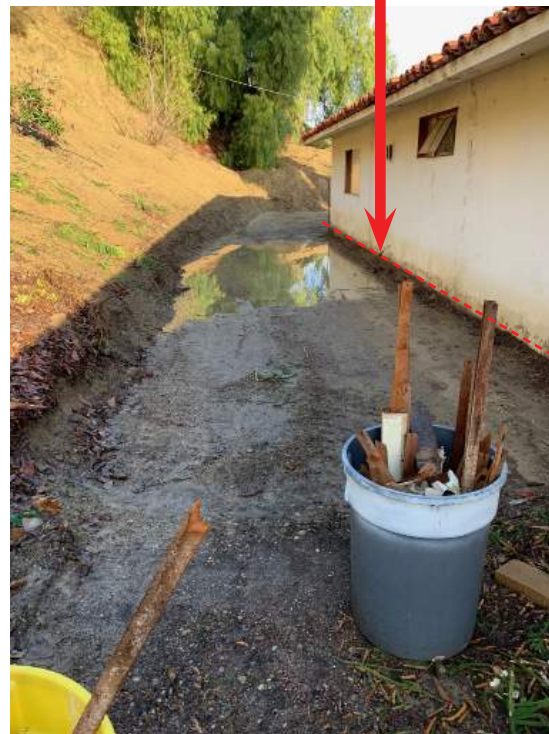
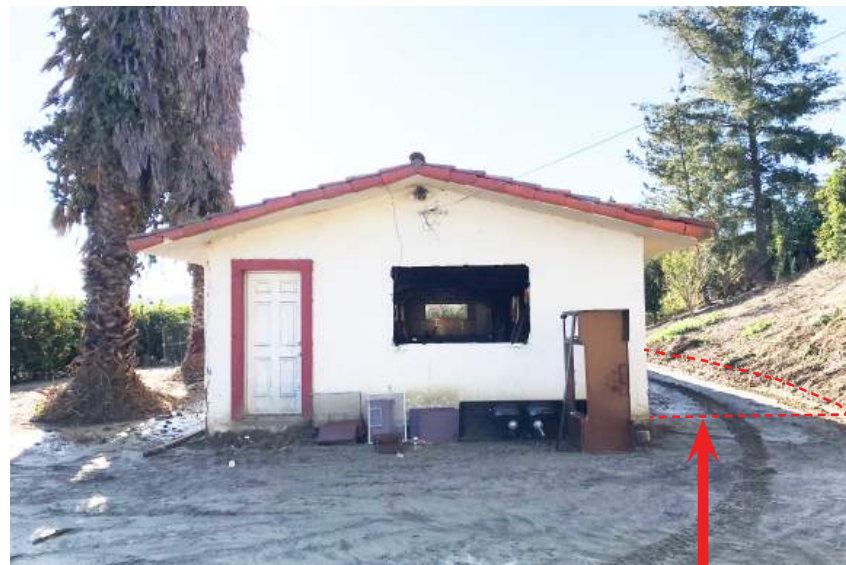
Floor Level

Original Grade

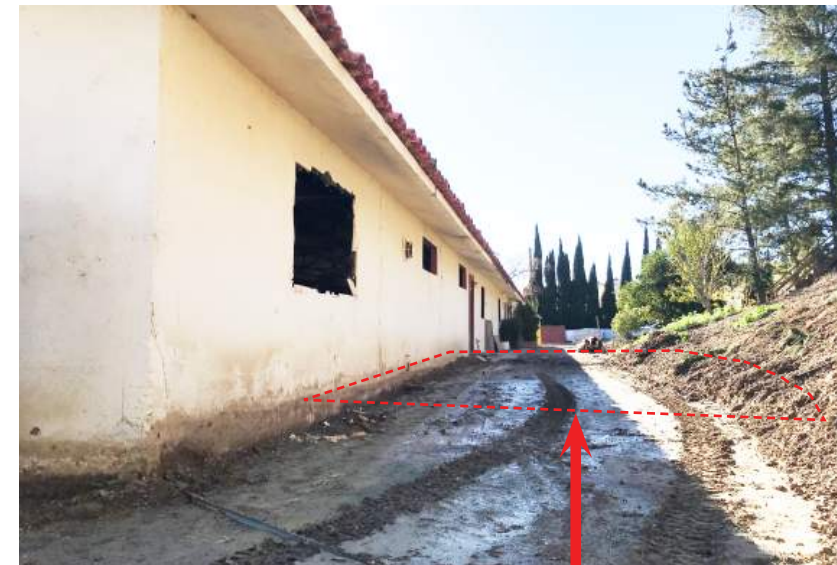
Level Before Cleanup

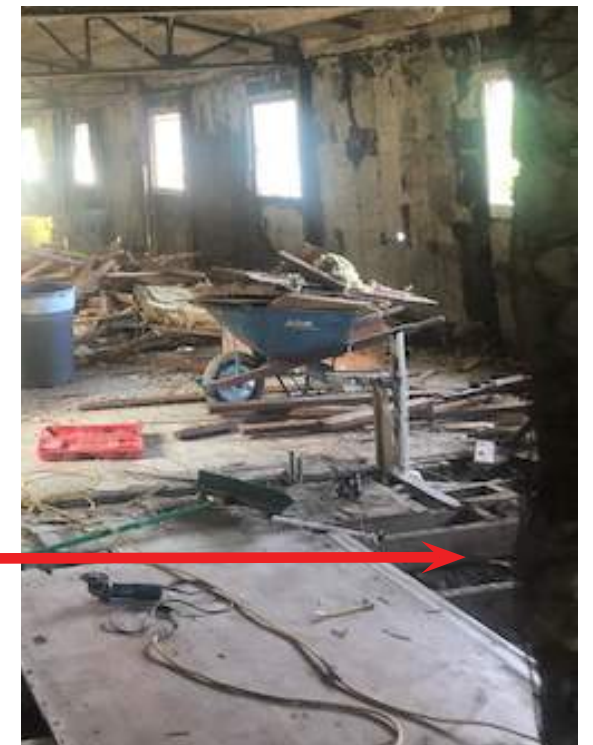
Only stucco remains

Dirt
