GEOTECHNICAL FEASIBILITY REPORT

FOR PROPOSED REBUILDING OF
LOWER AND MIDDLE CAMPS AT
CAMP HESS KRAMER,
11495 PACIFIC COAST HIGHWAY,
MALIBU AREA,
VENTURA COUNTY, CALIFORNIA

PROJECT NO.: 301529-002
FEBRUARY 25, 2020

BY
EARTH SYSTEMS PACIFIC
1731-A WALTER STREET
VENTURA, CALIFORNIA

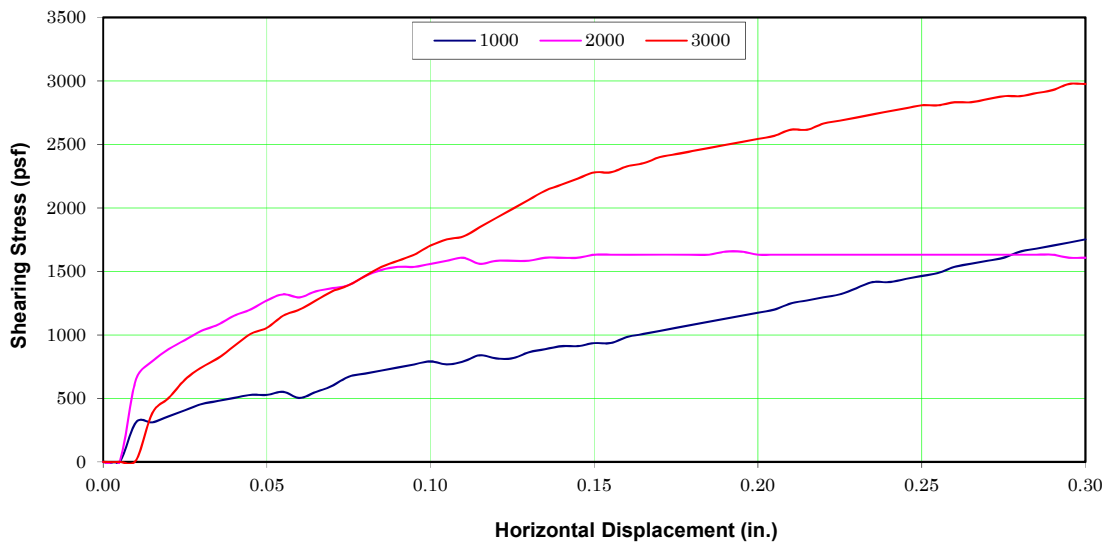
DIRECT SHEAR DATA*

Sample Location: B A 1 @ 10'
 Sample Description: Silty Gravel
 Dry Density (pcf): 118.1
 Initial % Moisture: 10
 Average Degree of Saturation: 100.0
 Shear Rate (in/min): 0.005 in/min

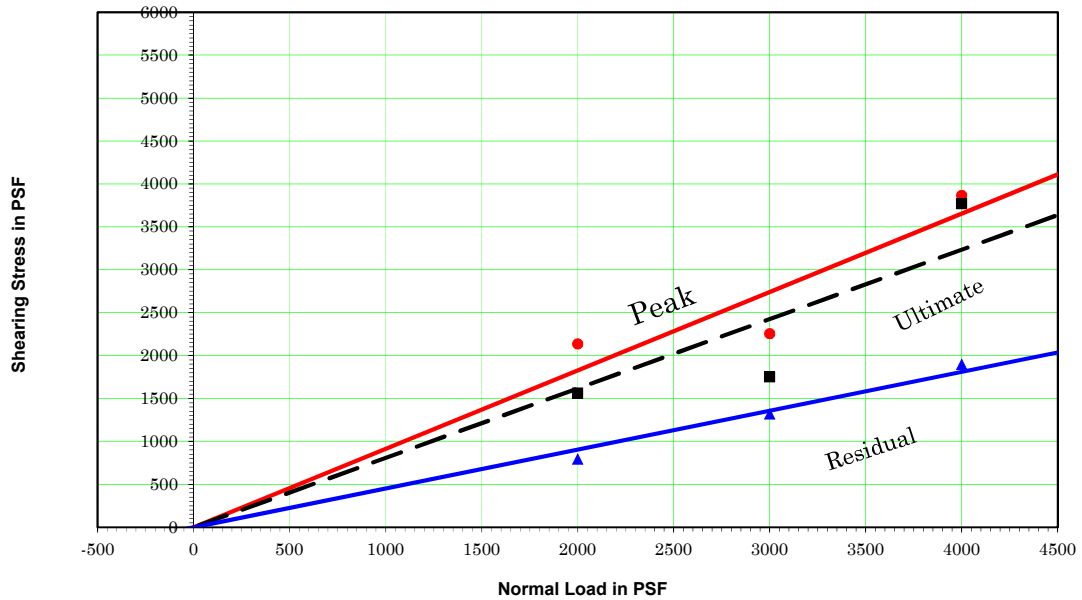
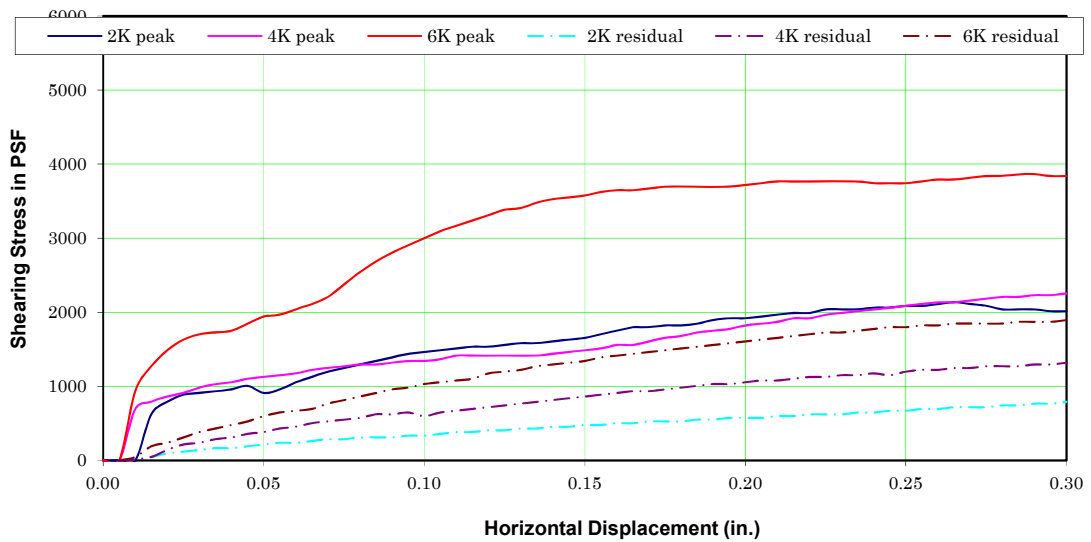
DIRECT SHEAR DATA*

Sample Location: B A 1 @ 30'

Initial Moisture (%): 6.5

Moisture at Test (%): 12.6

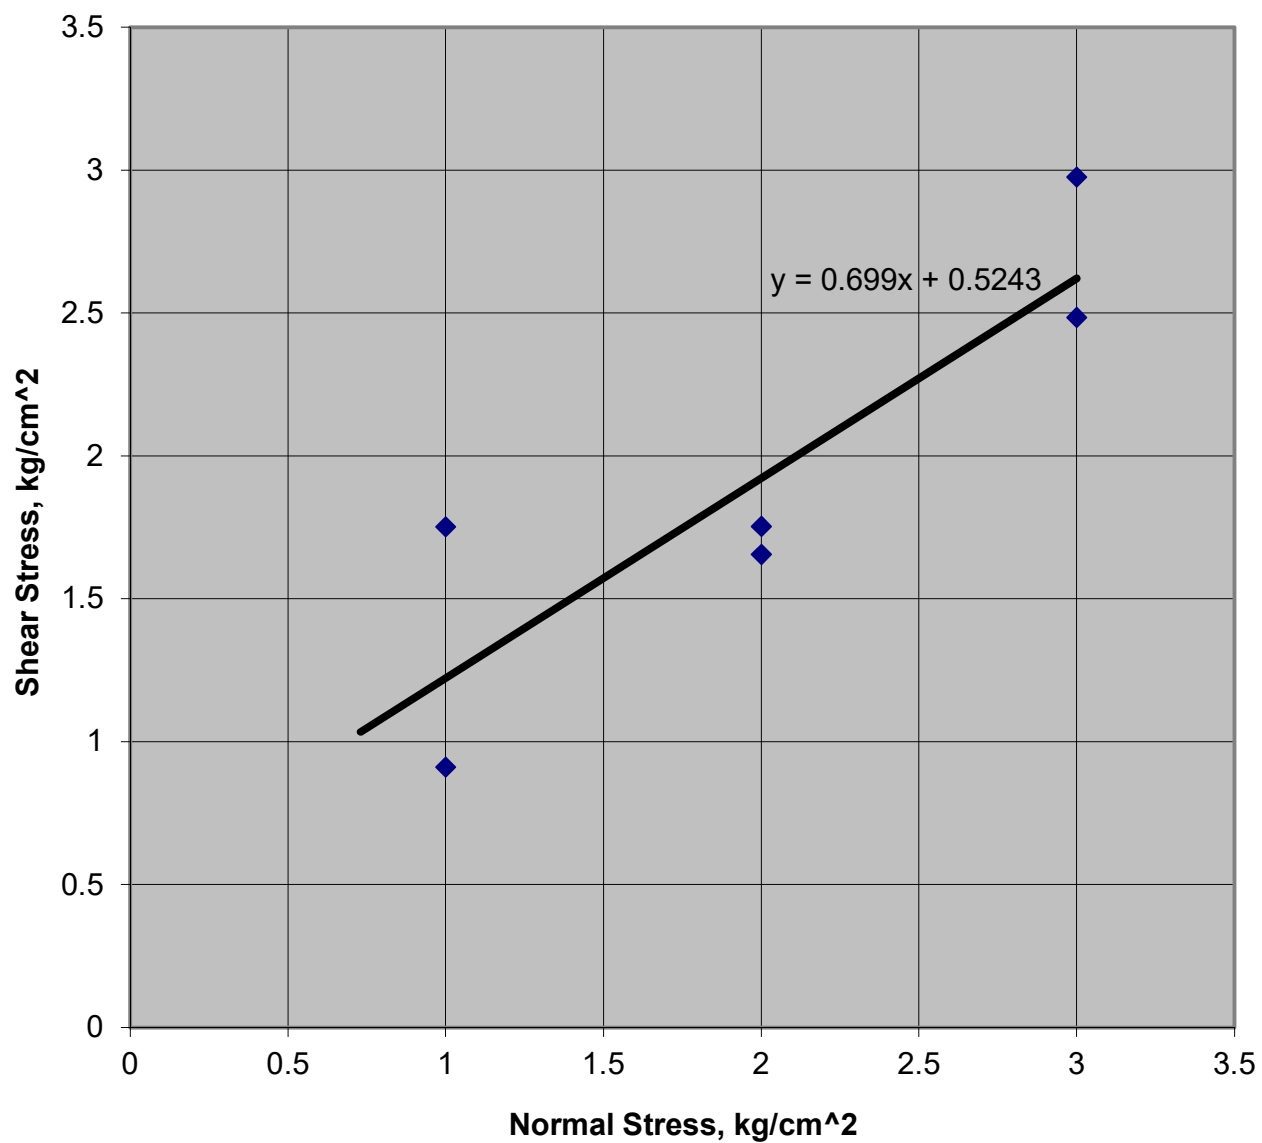
**Camp Hess Kramer
Peak Shear Slide Mass Material
Phi = 35.0 Degrees, Cohesion = 524 psf**

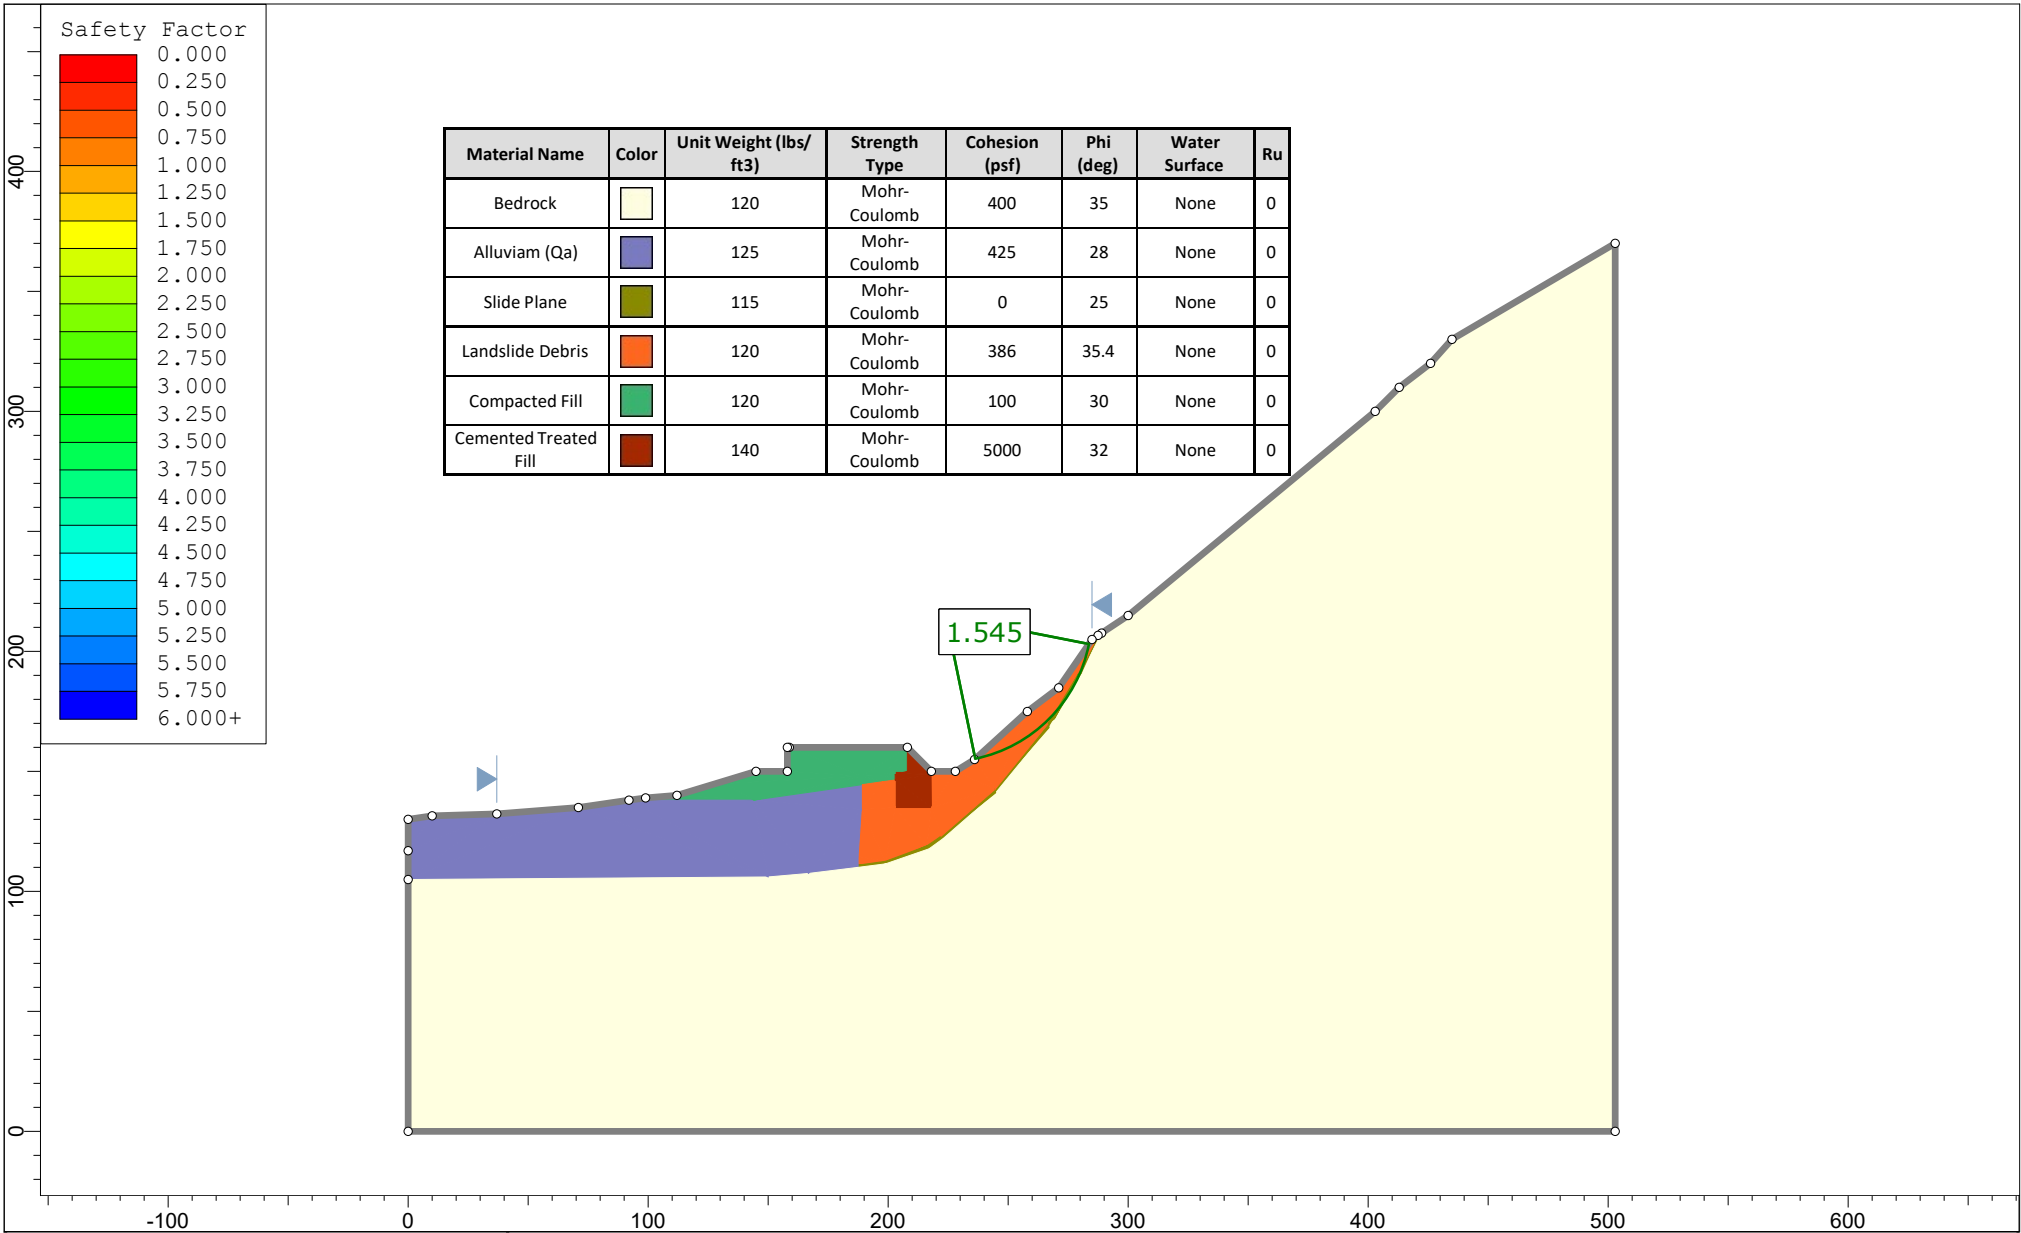
Project			Section A-A' - Static, Circular.slmd		
	Analysis Description			Group 1 - Master Scenario		
	Date	6/29/2020	Scale	1:960	Company	Earth Systems Pacific
	SLIDEINTERPRET 9.007

Material Name	Color	Unit Weight (lbs/ft3)	Strength Type	Cohesion (psf)	Phi (deg)	Water Surface	Ru
Bedrock		120	Mohr-Coulomb	400	35	None	0
Alluvium (Qa)		125	Mohr-Coulomb	425	28	None	0
Slide Plane		115	Mohr-Coulomb	0	25	None	0
Landslide Debris		120	Mohr-Coulomb	386	35.4	None	0
Compacted Fill		120	Mohr-Coulomb	100	30	None	0
Cemented Treated Fill		140	Mohr-Coulomb	5000	32	None	0

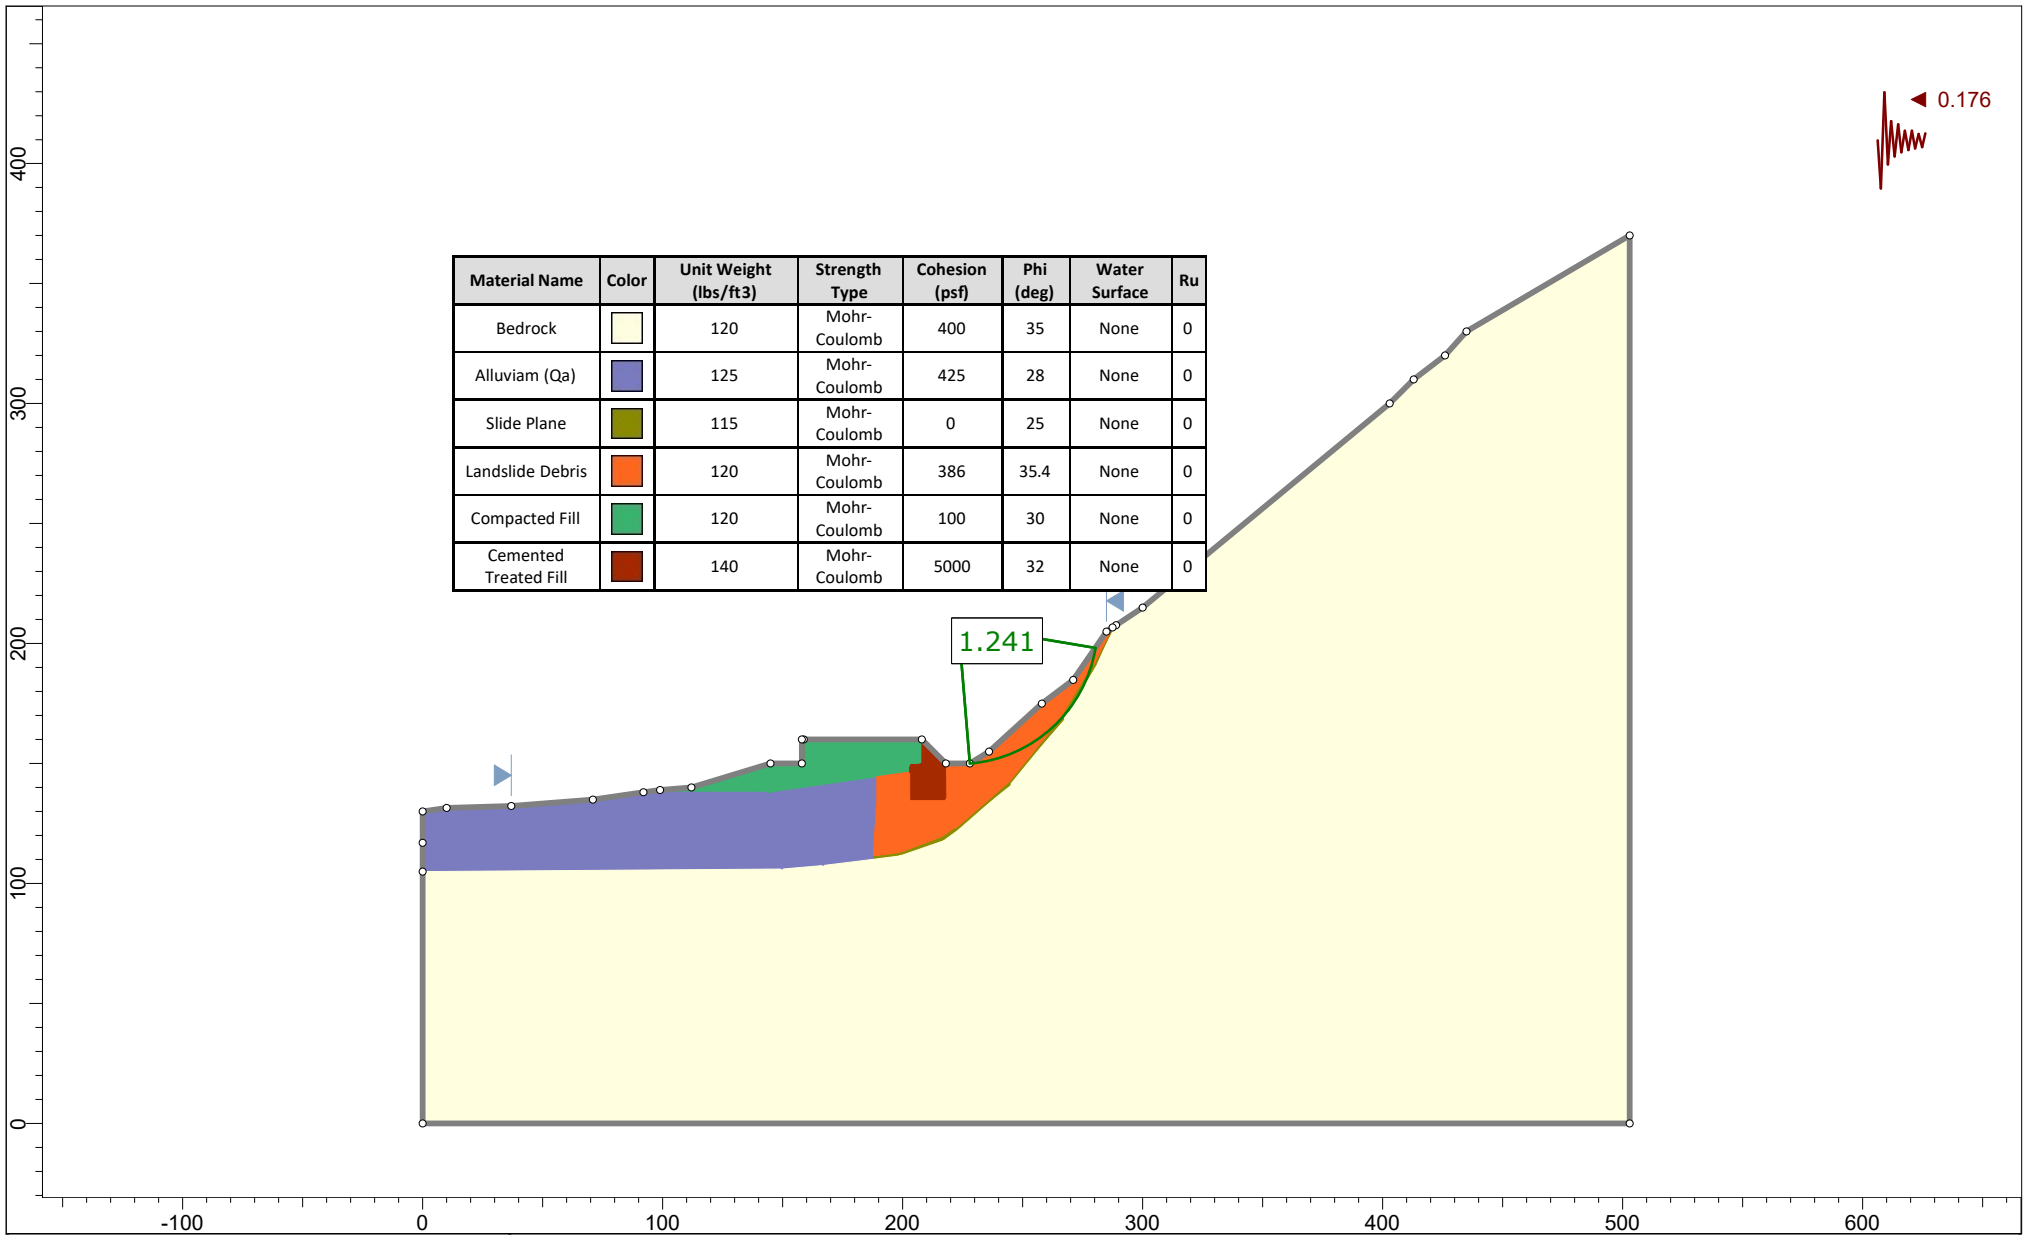
Project			Section A-A' - Seismic, Circular.slmd		
	Analysis Description			Group 1 - Master Scenario		
	Date	6/29/2020	Scale	1:960	Company	Earth Systems Pacific
	SLIDEINTERPRET 9.007

Material Name	Color	Unit Weight (lbs/ft3)	Strength Type	Cohesion (psf)	Phi (deg)	Water Surface	Ru
Bedrock	Yellow	120	Mohr-Coulomb	400	35	None	0
Alluvium (Qa)	Purple	125	Mohr-Coulomb	425	28	None	0
Slide Plane	Green	115	Mohr-Coulomb	0	25	None	0
Landslide Debris	Orange	120	Mohr-Coulomb	386	35.4	None	0
Compacted Fill	Light Green	120	Mohr-Coulomb	100	30	None	0
Cemented Treated Fill	Brown	140	Mohr-Coulomb	5000	32	None	0

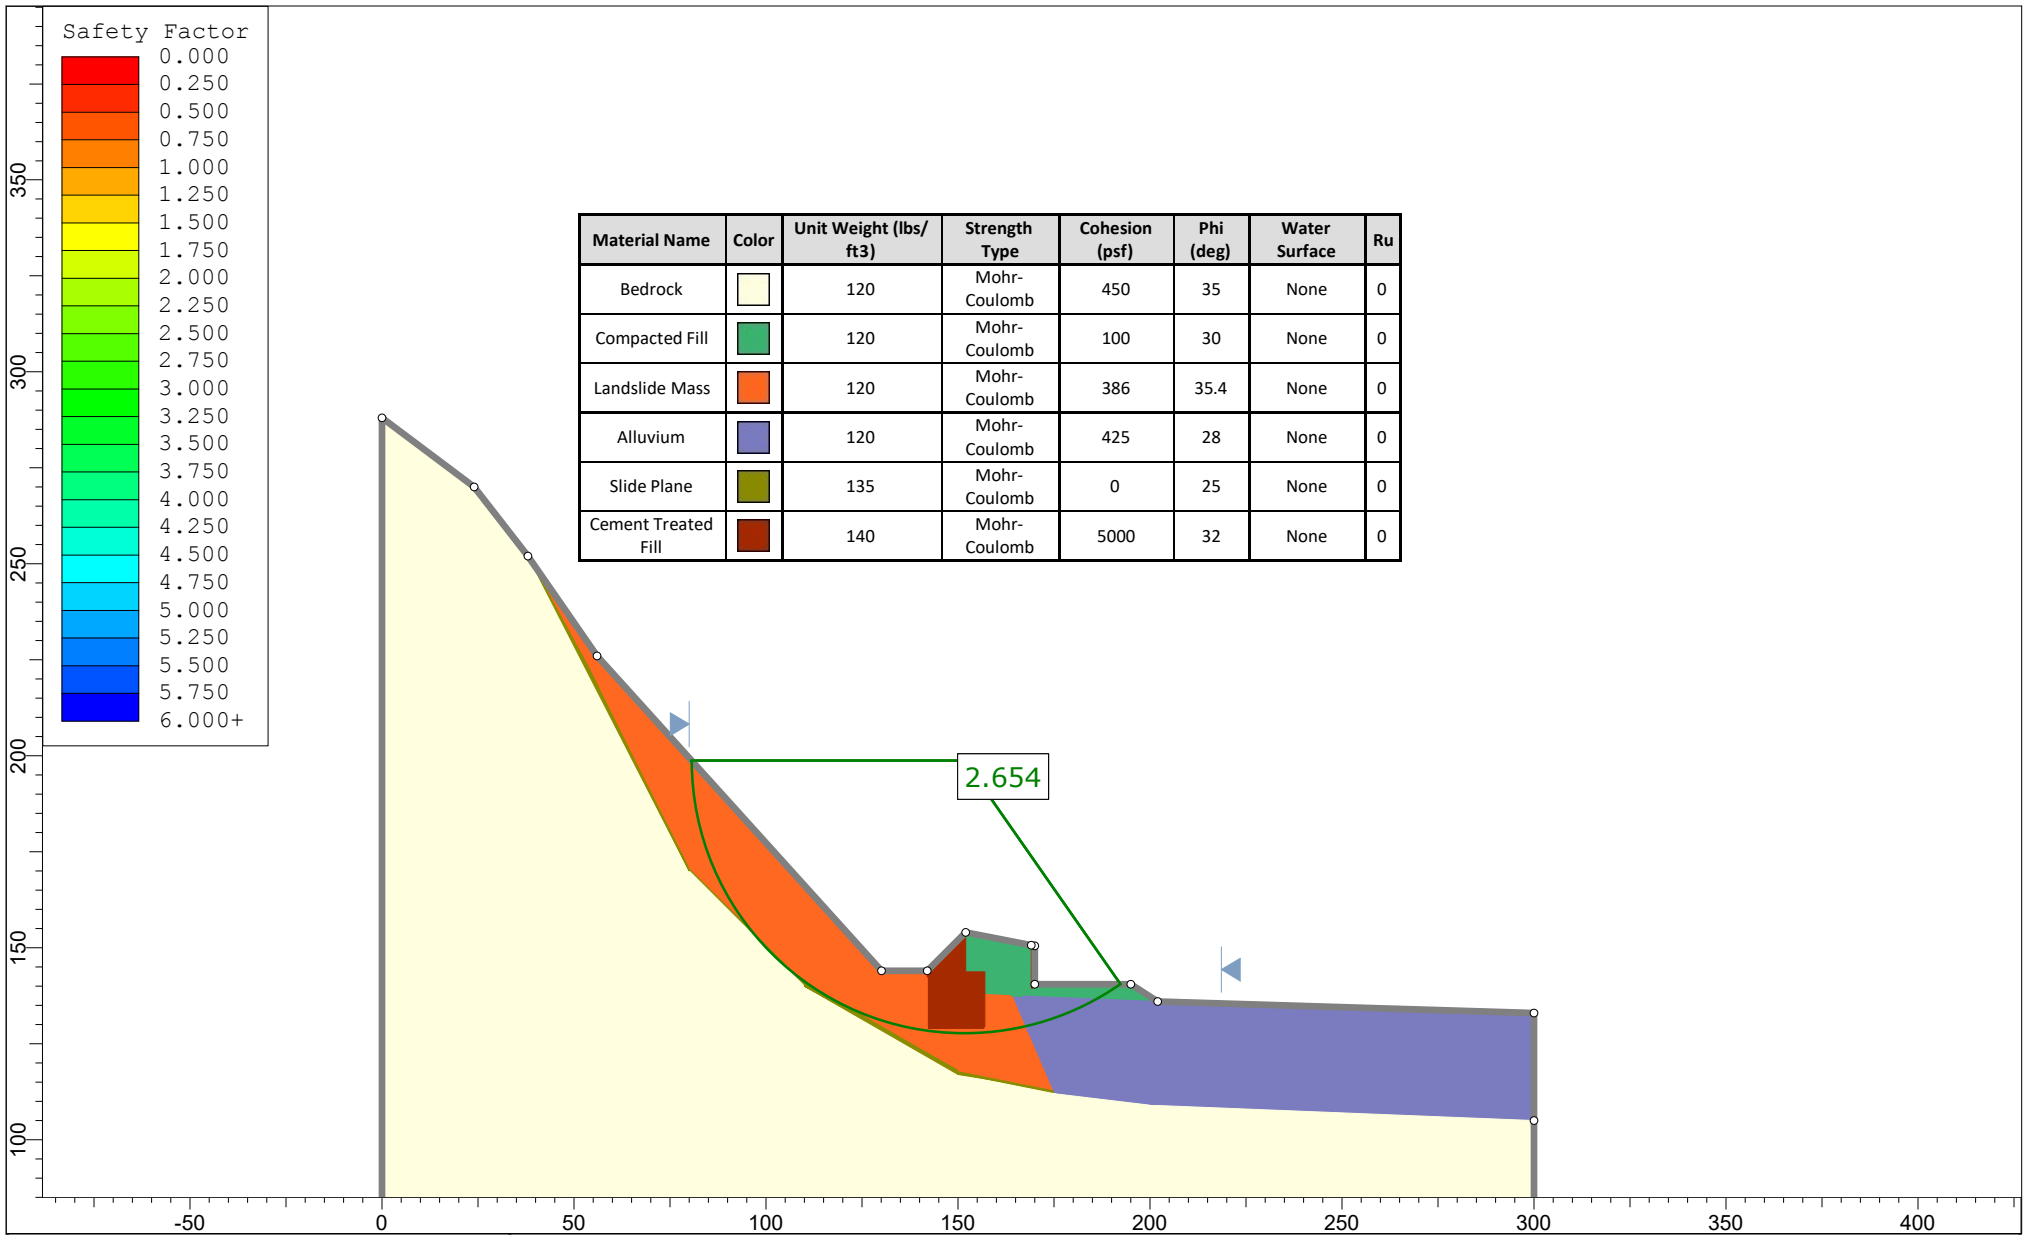
<i>Project</i> Section B-B' - Static, Circular.slmd		
	<i>Analysis Description</i> Group 1 - Master Scenario		
	<i>Date</i> 7/1/2020	<i>Scale</i> 1:600	<i>Company</i> Earth Systems Pacific
	SLIDEINTERPRET 9.007

Material Name	Color	Unit Weight (lbs/ft3)	Strength Type	Cohesion (psf)	Phi (deg)	Water Surface	Ru
Bedrock		120	Mohr-Coulomb	450	35	None	0
Compacted Fill		120	Mohr-Coulomb	100	30	None	0
Landslide Mass		120	Mohr-Coulomb	386	35.4	None	0
Alluvium		120	Mohr-Coulomb	425	28	None	0
Slide Plane		135	Mohr-Coulomb	0	25	None	0
Cement Treated Fill		140	Mohr-Coulomb	5000	32	None	0

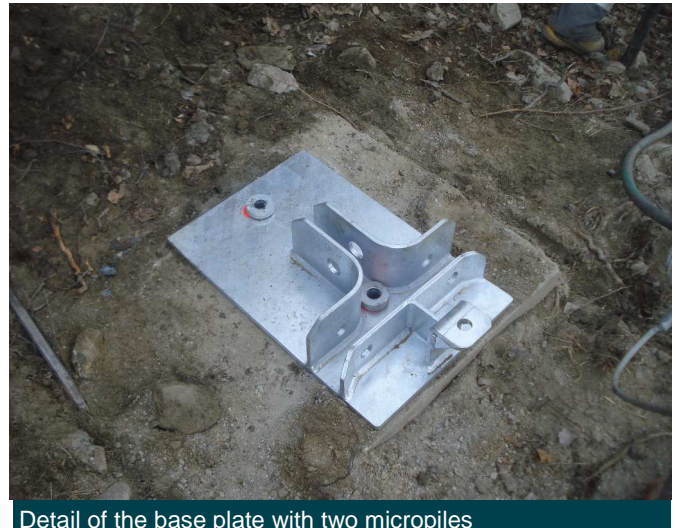
Detail of the base plate with two micropiles
